***PHASE I REVIEW & PHASE II STRATEGIC
GEO-ENVIRONMENTAL ASSESSMENT***

***LAND SOUTH AND EAST OF ADASTRAL PARK
MARTLESHAM HEATH
IPSWICH
SUFFOLK
IP10 0BL***

JANUARY 2017 (Rev01)

Project Reference: GEG-16-458

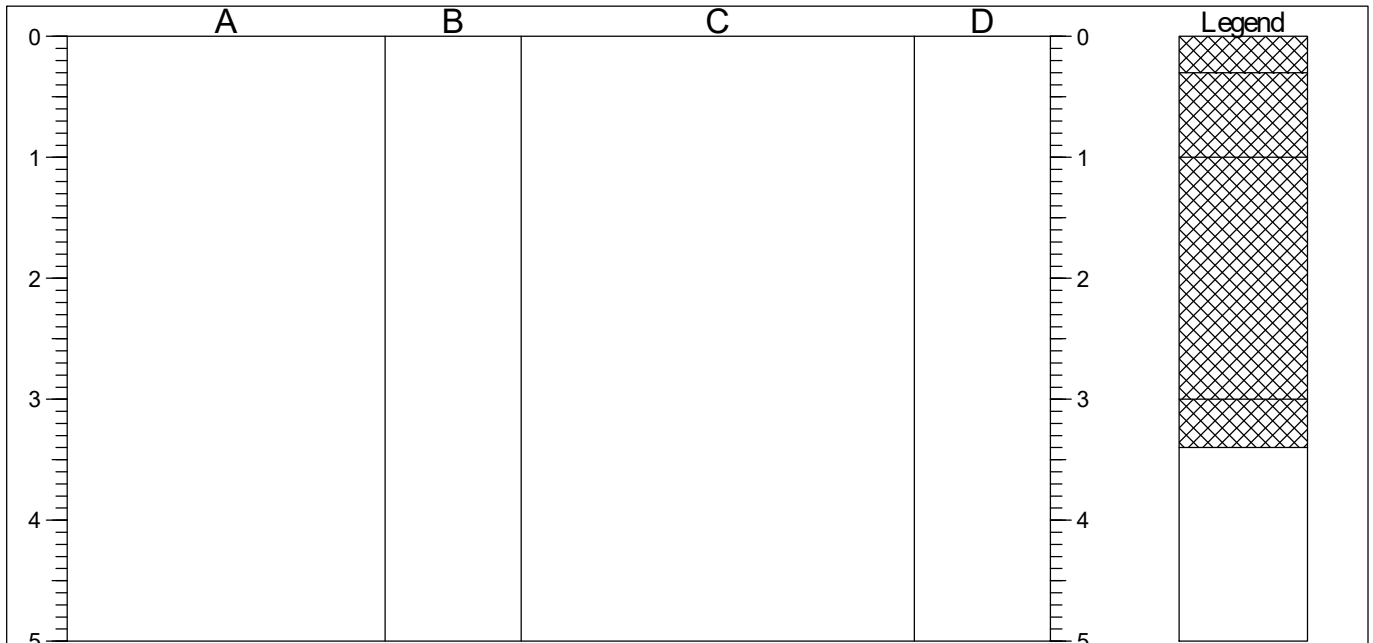
Project Adastral Park, Ipswich, IP10 0BL - Area 1				TRIAL PIT No TP03
Job No GEG-16-458	Date 22-09-16	Ground Level (m)	Co-Ordinates () E 625,865.0 N 244,796.0	
Contractor				Sheet 1 of 1

STRATA			SAMPLES & TESTS		
Depth	No	DESCRIPTION	Depth	No	Remarks/Tests
0.00-0.30		MADE GROUND - (Loose) brown silty fine SAND with occasional rootlets. (REWORKED TOPSOIL)

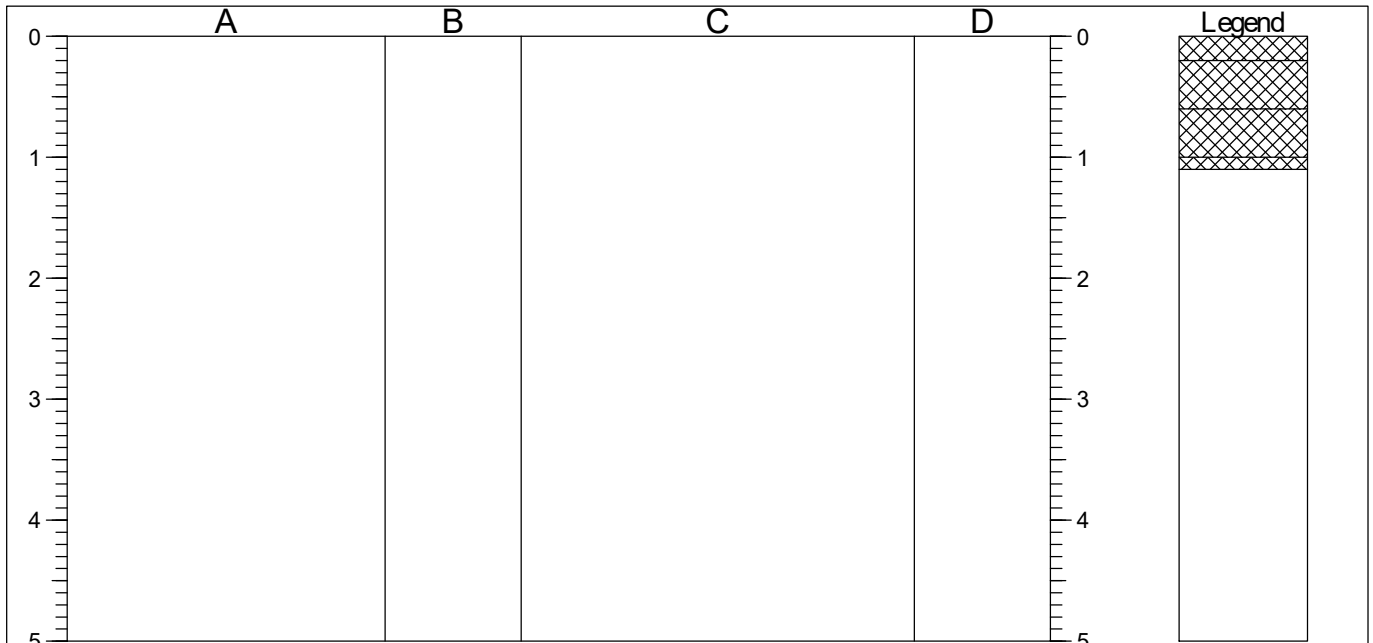
Project Adastral Park, Ipswich, IP10 0BL - Area 1				TRIAL PIT No TP04
Job No GEG-16-458	Date 21-09-16	Ground Level (m)	Co-Ordinates () E 625,990.9 N 244,851.8	
Contractor				Sheet 1 of 1

STRATA			SAMPLES & TESTS		
Depth	No	DESCRIPTION	Depth	No	Remarks/Tests
0.00-0.20		MADE GROUND - (Loose) yellowish brown slightly clayey gravelly medium SAND. Gravel is sub-rounded quartzite, flint.	0.30	D	
0.20-0.60					
0.60-1.00		MADE GROUND - (Loose to medium dense) brown slightly clayey slightly gravelly medium SAND. Gravel is sub-angular various lithologies.	0.50	D	
1.00-1.10		MADE GROUND - (Medium dense) grey and greyish brown very gravelly medium SAND with occasional gravel to cobble-sized fragments of tarmacadam, rebar, pottery and glass. Gravel is sub-rounded quartzite and flint, and sub-angular brick and concrete.			
		MADE GROUND - (Very dense) reddish brown and grey COBBLES of brick and concrete.

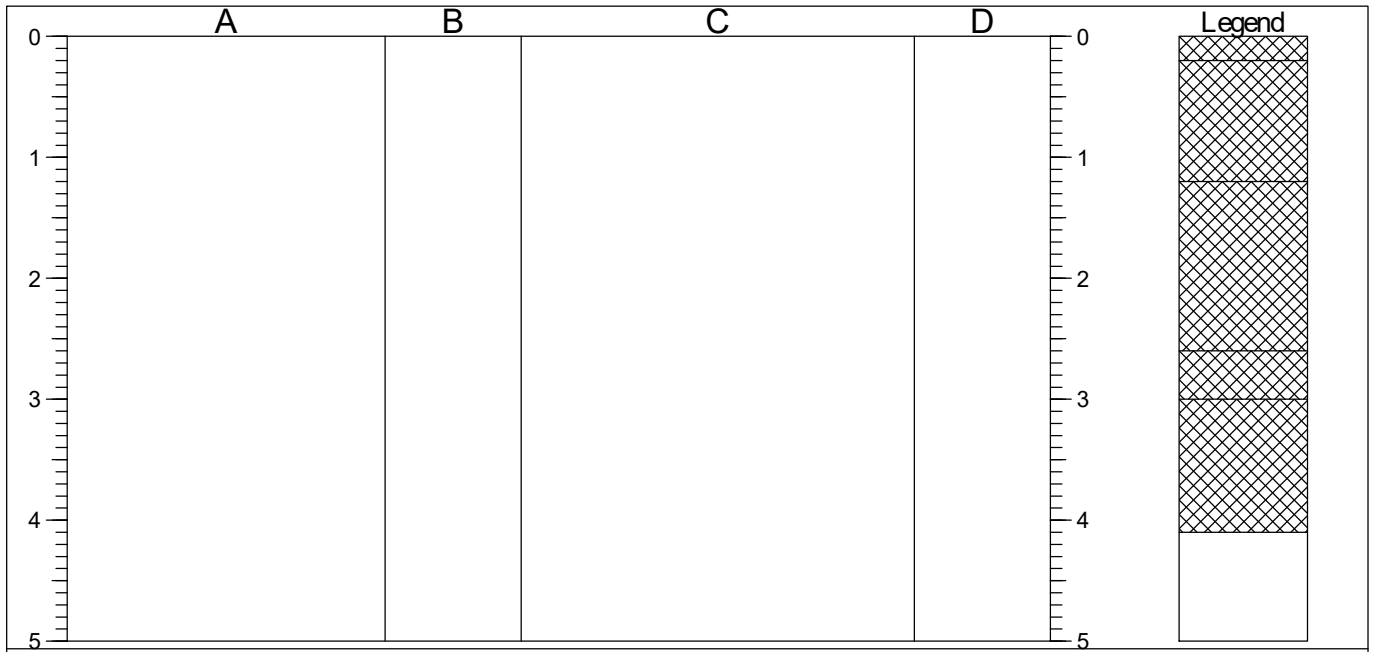
Project Adastral Park, Ipswich, IP10 0BL - Area 1				TRIAL PIT No TP05
Job No GEG-16-458	Date 22-09-16	Ground Level (m)	Co-Ordinates () E 625,870.9 N 244,715.6	
Contractor				Sheet 1 of 1

STRATA			SAMPLES & TESTS		
Depth	No	DESCRIPTION	Depth	No	Remarks/Tests
0.00-0.20		MADE GROUND - (Loose) brown silty fine SAND with occasional rootlets.

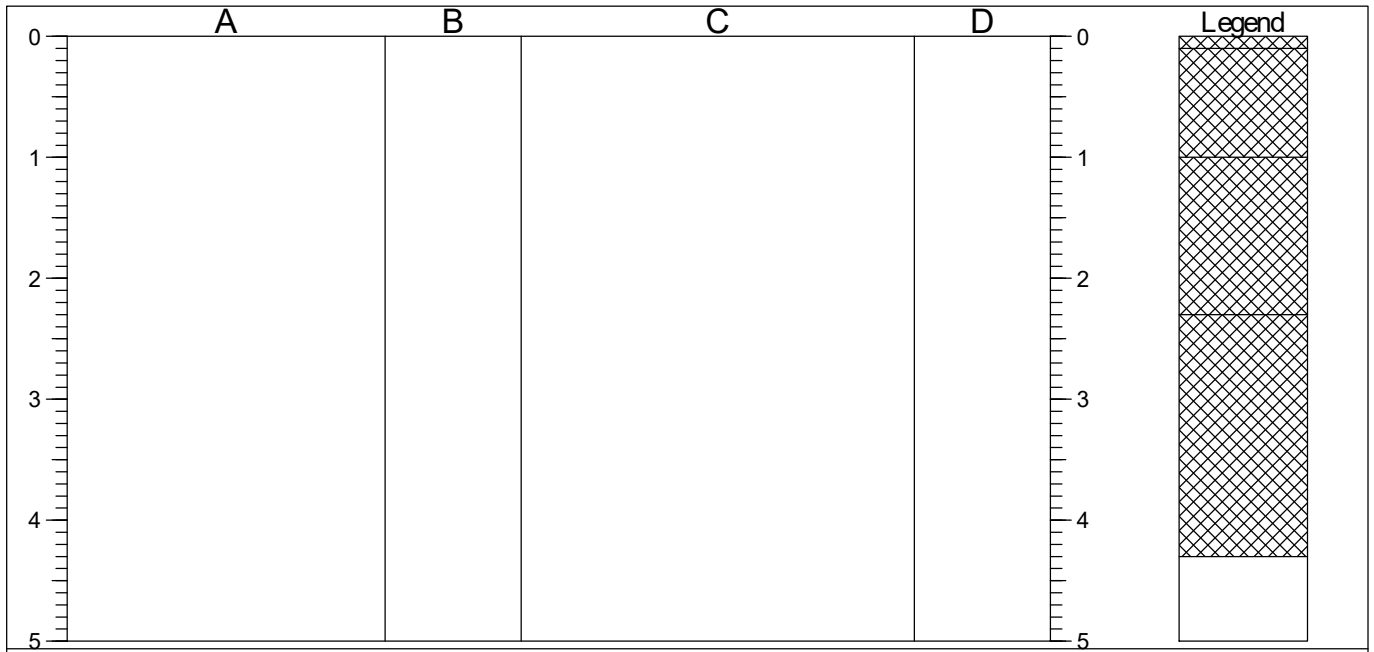
Project Adastral Park, Ipswich, IP10 0BL - Area 1				TRIAL PIT No TP06
Job No GEG-16-458	Date 22-09-16	Ground Level (m)	Co-Ordinates () E 625,944.8 N 244,622.5	
Contractor				Sheet 1 of 1

STRATA			SAMPLES & TESTS		
Depth	No	DESCRIPTION	Depth	No	Remarks/Tests
0.00-0.10		MADE GROUND - (Loose) brown silty fine SAND with occasional rootlets.

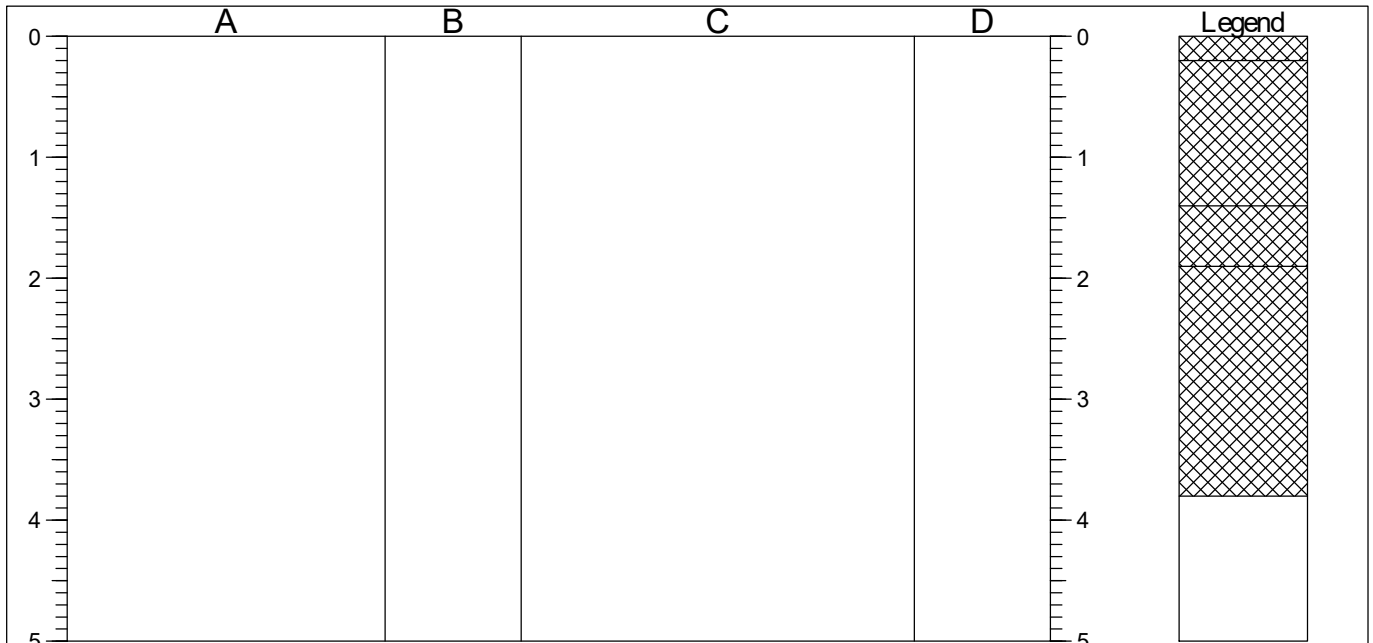
Project Adastral Park, Ipswich, IP10 0BL - Area 1				TRIAL PIT No TP07
Job No GEG-16-458	Date 21-09-16	Ground Level (m)	Co-Ordinates () E 625,947.7 N 244,696.8	
Contractor				Sheet 1 of 1

STRATA			SAMPLES & TESTS		
Depth	No	DESCRIPTION	Depth	No	Remarks/Tests
0.00-0.20		MADE GROUND - (Loose) brown silty fine SAND with occasional rootlets.	0.30	D

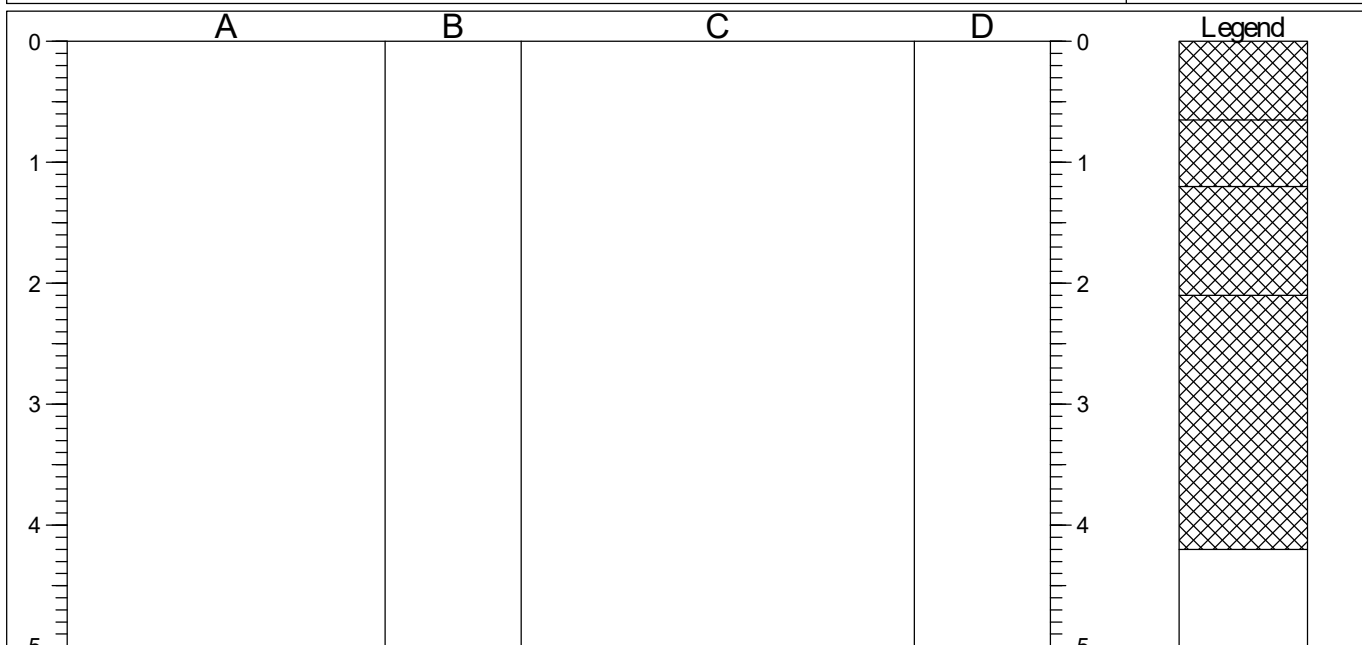
Project Adastral Park, Ipswich, IP10 0BL - Area 1				TRIAL PIT No TP08
Job No GEG-16-458	Date 22-09-16	Ground Level (m)	Co-Ordinates () E 625,936.6 N 244,750.8	
Contractor				Sheet 1 of 1

STRATA			SAMPLES & TESTS		
Depth	No	DESCRIPTION	Depth	No	Remarks/Tests
0.00-0.65		MADE GROUND - (Loose) brown silty fine SAND with occasional rootlets. (REWORKED TOPSOIL)	0.60	D	
0.65-1.20		MADE GROUND - (Medium dense) yellowish grey medium SAND.			
1.20-2.10		MADE GROUND - (Firm) friable grey slightly sandy gravelly CLAY with occasional cobble-sized fragments of brick and concrete. Gravel is sub-rounded chert, brick and concrete.			
2.10-4.20		MADE GROUND - (Firm) friable grey gravelly CLAY with occasional cobble to boulder-sized pockets of brown sand; and with numerous cobble-sized fragments of timber, plastic and metal. Gravel is medium fragments of brick and concrete.

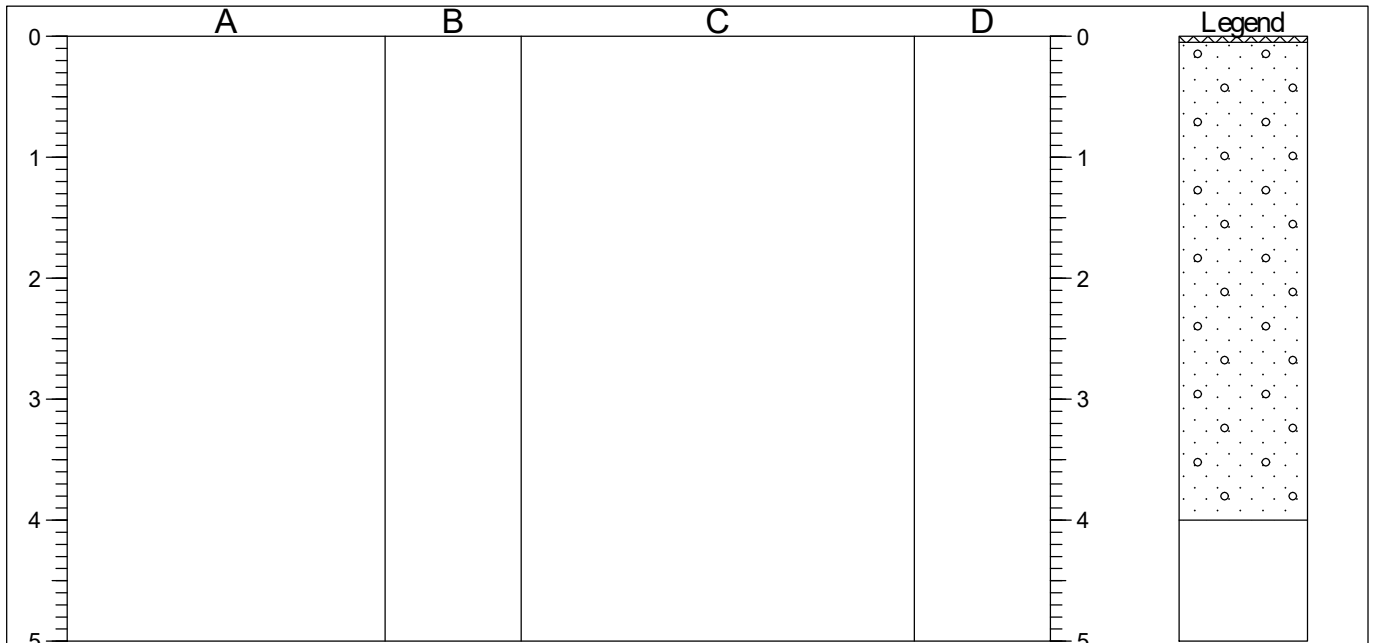
Project Adastral Park, Ipswich, IP10 0BL - Area 1				TRIAL PIT No TP09
Job No GEG-16-458	Date 21-09-16	Ground Level (m)	Co-Ordinates () E 626,112.7 N 244,795.1	
Contractor				Sheet 1 of 1

STRATA			SAMPLES & TESTS		
Depth	No	DESCRIPTION	Depth	No	Remarks/Tests
0.00-0.05		MADE GROUND - (Loose) brown clayey gravelly medium SAND with occasional gravel-sized metal fragments.			
0.05-4.00		(Medium dense) yellowish brown and orangish brown slightly gravelly medium SAND. Gravel is sub-angular to sub-rounded ferrous sandstone. (KESGRAVE CATCHMENT SUBGROUP)	0.50	D	
		1.40 - 4.00 Becoming orangish brown with occasional cobbles	1.40	B

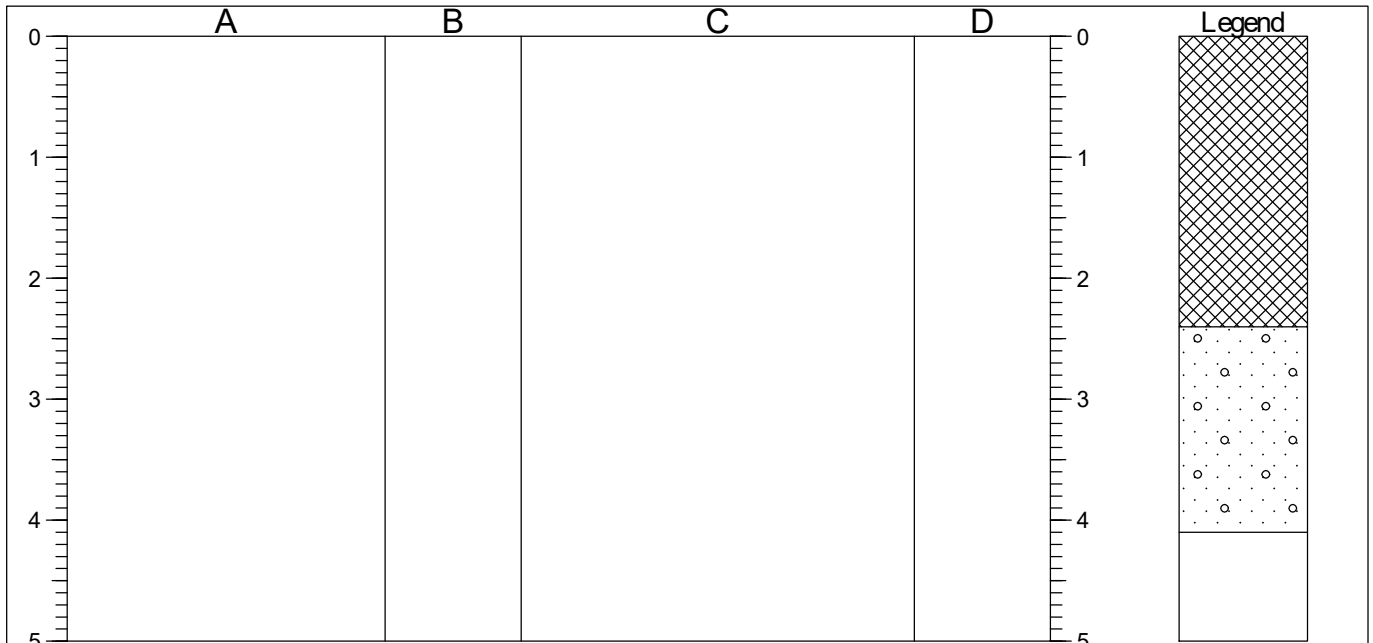
Project Adastral Park, Ipswich, IP10 0BL - Area 1				TRIAL PIT No TP10	
Job No GEG-16-458	Date 21-09-16	Ground Level (m)	Co-Ordinates () E 626,160.2 N 244,715.1		
Contractor				Sheet 1 of 1

STRATA			SAMPLES & TESTS		
Depth	No	DESCRIPTION	Depth	No	Remarks/Tests
0.00-2.40		MADE GROUND - (Loose to medium dense) brown very clayey gravelly medium SAND with occasional gravel-sized fragments of concrete, glass and road gravel. Gravel is sub-rounded quartzite and flint.	0.30	D	
2.40-4.10		(Medium dense) yellowish brown and orangish brown slightly gravelly medium SAND. Gravel is sub-angular to sub-rounded sandstone and ferrous sandstone. (KESGRAVE CATCHMENT SUBGROUP) 3.00 - 4.10 Becoming reddish brown with occasional cobbles.	1.70	B

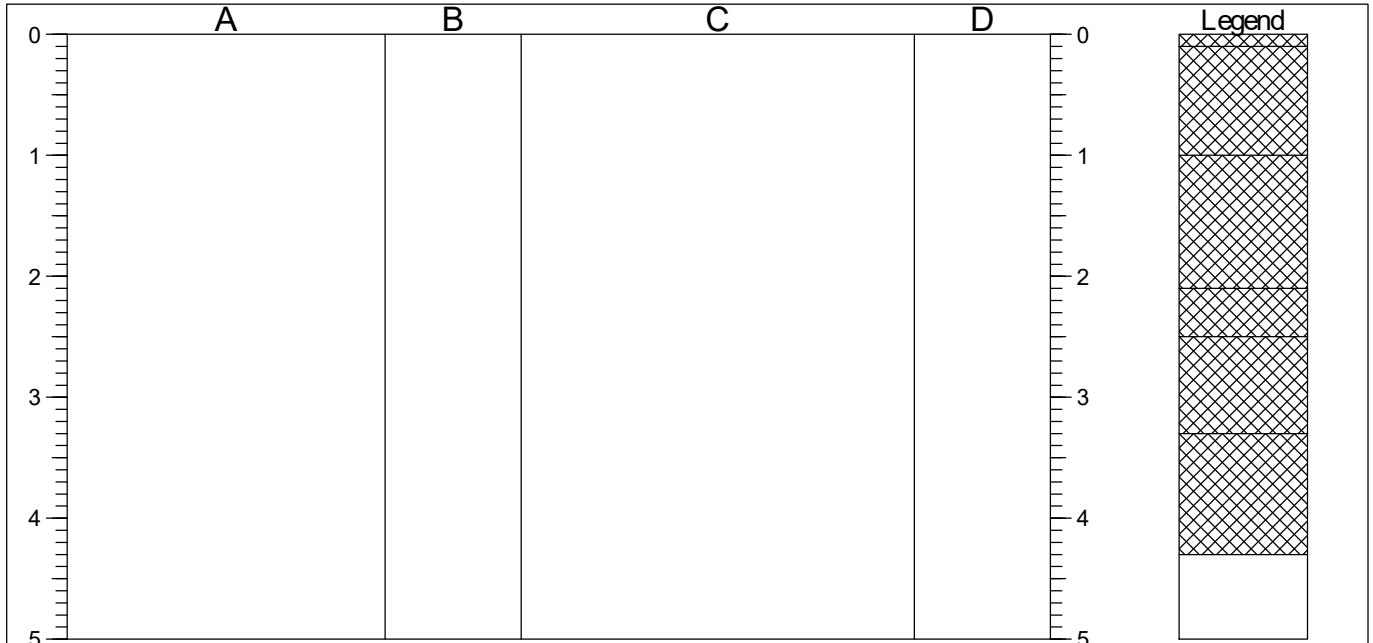
Project Adastral Park, Ipswich, IP10 0BL - Area 1				TRIAL PIT No TP11
Job No GEG-16-458	Date 21-09-16	Ground Level (m)	Co-Ordinates () E 626,032.3 N 244,693.0	
Contractor				Sheet 1 of 1

STRATA			SAMPLES & TESTS		
Depth	No	DESCRIPTION	Depth	No	Remarks/Tests
0.00-0.10		MADE GROUND - (Loose) brown silty fine SAND with occasional rootlets.	0.30	D

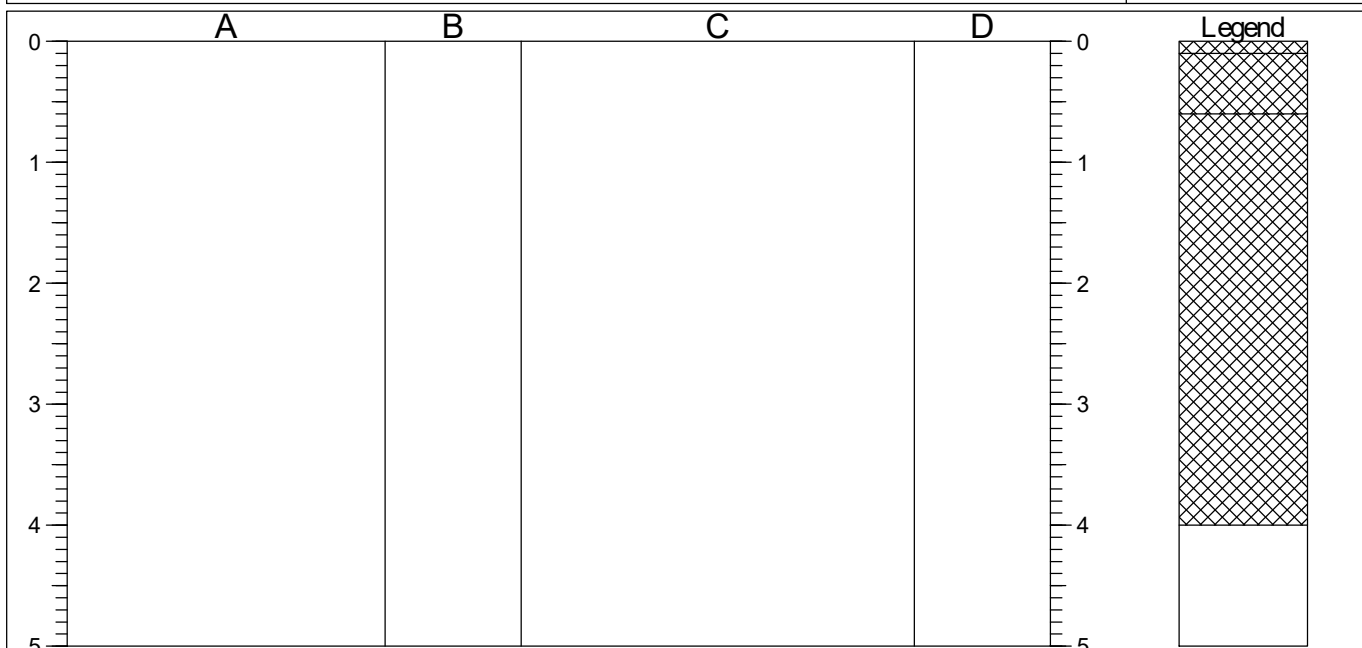
Project Adastral Park, Ipswich, IP10 0BL - Area 1				TRIAL PIT No TP12
Job No GEG-16-458	Date 21-09-16	Ground Level (m)	Co-Ordinates () E 625,982.7 N 244,645.2	
Contractor				Sheet 1 of 1

STRATA			SAMPLES & TESTS		
Depth	No	DESCRIPTION	Depth	No	Remarks/Tests
0.00-0.10		MADE GROUND - (Loose) brown silty fine SAND with occasional rootlets.			
0.10-0.60		(REWORKED TOPSOIL)			
0.60-4.00		MADE GROUND - (Medium dense) brown slightly gravelly medium SAND. Gravel is sub-rounded quartzite and flint.	0.50	D	
		MADE GROUND - (Firm) friable greyish brown and brown silty slightly sandy gravelly CLAY with occasional cobble to boulder-sized pockets of sand. Gravel is sub-rounded chert and flint.	1.00	B	
		3.00 - 3.20 Becoming dark brown with slightly peaty odour			
		3.70 - 4.00 With occasional cobble-sized fragments of brick and flint

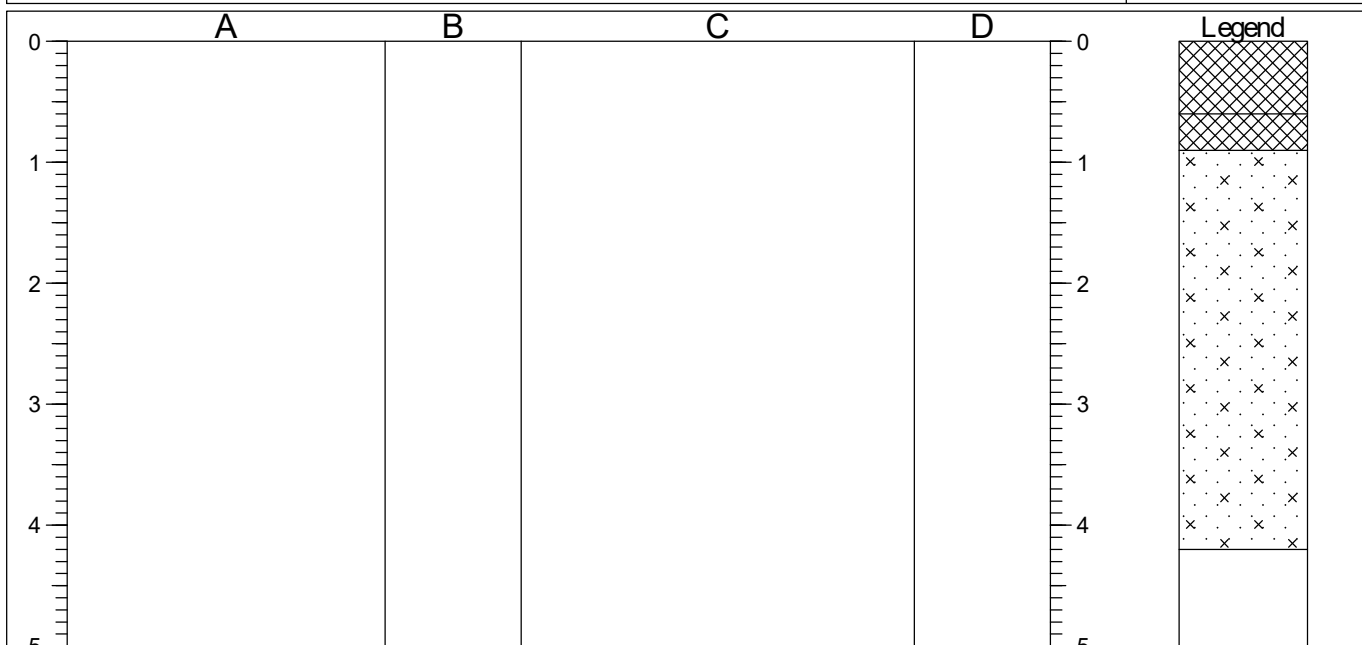
Project Adastral Park, Ipswich, IP10 0BL - Area 1				TRIAL PIT No TP13
Job No GEG-16-458	Date 21-09-16	Ground Level (m)	Co-Ordinates () E 626,164.8 N 244,609.1	
Contractor				Sheet 1 of 1

STRATA			SAMPLES & TESTS		
Depth	No	DESCRIPTION	Depth	No	Remarks/Tests
0.00-0.60		MADE GROUND - (Loose) brown silty fine SAND with occasional rootlets. (REWORKED TOPSOIL)	0.40	D	
0.60-0.90		MADE GROUND - (Medium dense) brown slightly silty gravelly fine to medium SAND. Gravel is sub-rounded quartzite and flint.	0.95	B	
0.90-4.20		(Medium dense) bluish grey and brownish grey silty fine to medium SAND with occasional whole shells. (WEATHERED RED CRAG FORMATION) 1.20 - 4.20 Becoming bluish grey very silty slightly gravelly. Gravel is sub-rounded to sub-angular siltstone and flint.

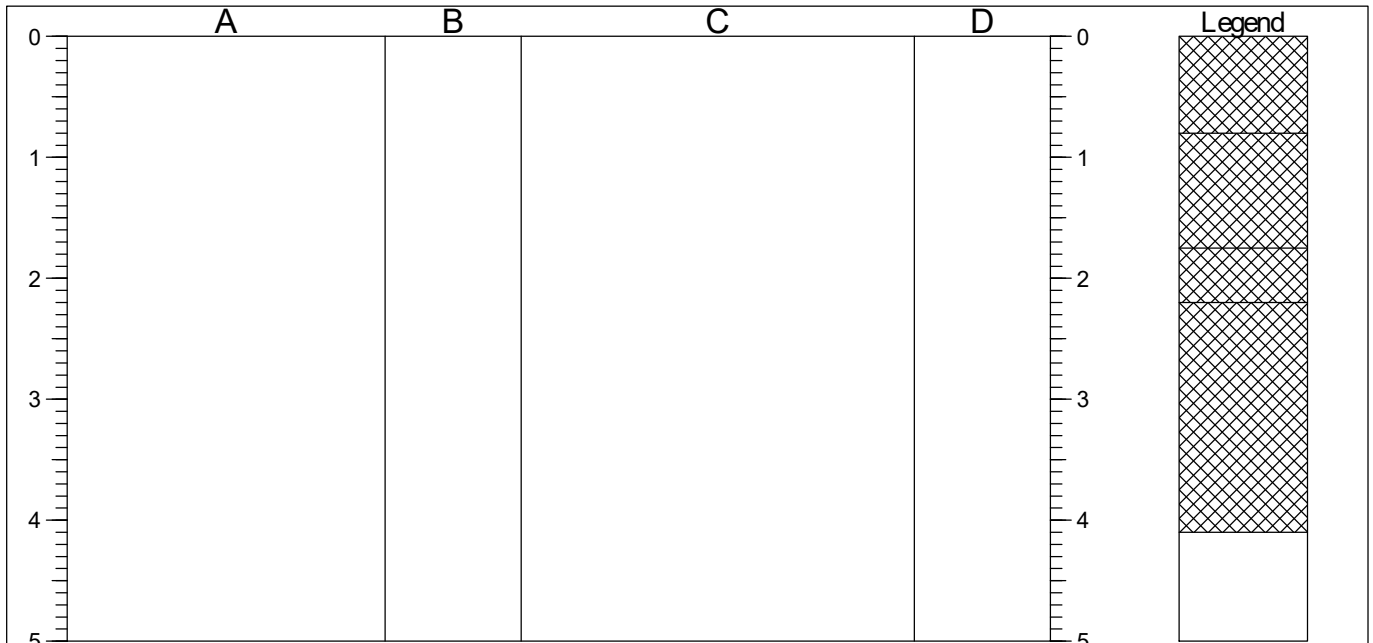
Project Adastral Park, Ipswich, IP10 0BL - Area 1				TRIAL PIT No TP14
Job No GEG-16-458	Date 21-09-16	Ground Level (m)	Co-Ordinates () E 626,158.7 N 244,667.0	
Contractor				Sheet 1 of 1

STRATA			SAMPLES & TESTS		
Depth	No	DESCRIPTION	Depth	No	Remarks/Tests
0.00-0.80		MADE GROUND - (Loose to medium dense) brown very clayey gravelly medium SAND. Gravel is sub-rounded to sub-angular flint and brick.	0.40	D

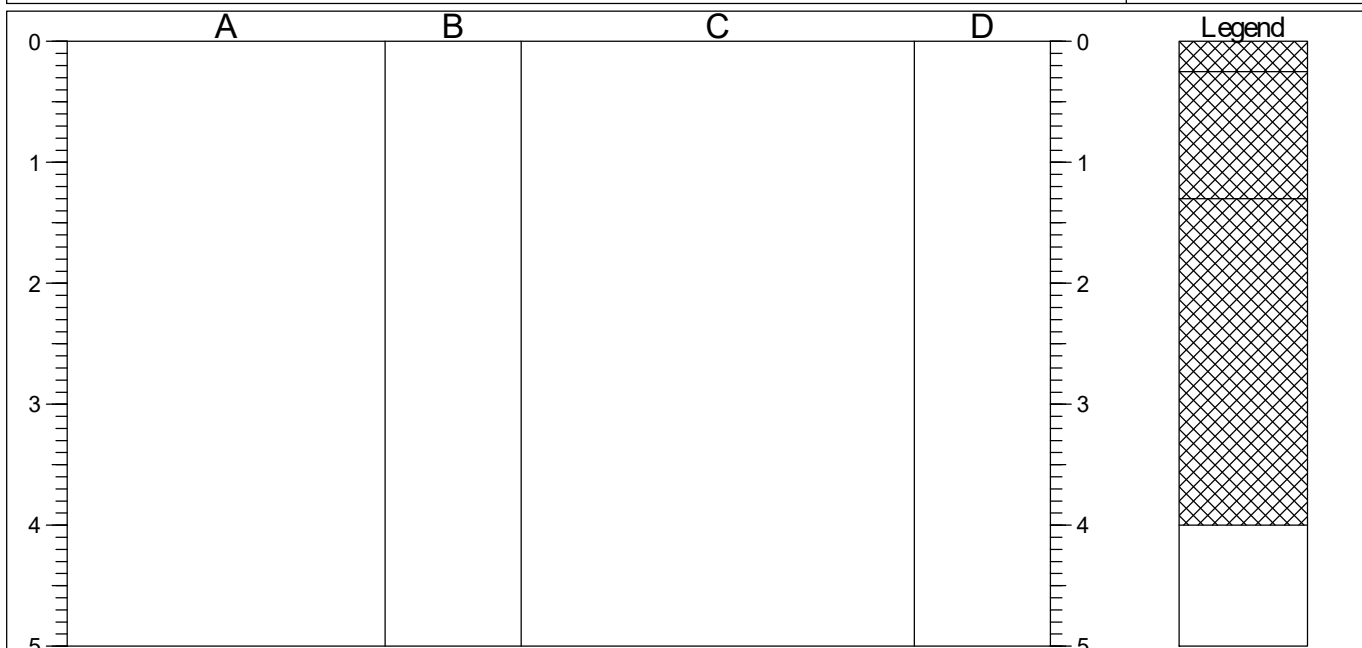
Project Adastral Park, Ipswich, IP10 0BL - Area 1				TRIAL PIT No TP15
Job No GEG-16-458	Date 21-09-16	Ground Level (m)	Co-Ordinates () E 626,108.1 N 244,644.2	
Contractor				Sheet 1 of 1

STRATA			SAMPLES & TESTS		
Depth	No	DESCRIPTION	Depth	No	Remarks/Tests
0.00-0.25		MADE GROUND - (Loose) dark brown slightly gravelly fine to medium SAND with occasional rootlets. Gravel is sub-rounded quartzite and flint. (REWORKED TOPSOIL)	0.30	D	
0.25-1.30					
1.30-4.00		MADE GROUND - (Medium dense) brown slightly gravelly to gravelly fine to medium SAND. Gravel is sub-rounded quartzite and flint.	1.40	B	
		1.40 - 4.00 With occasional cobble to boulder-sized fragments of timber, concrete, plastic, ash and charcoal. Gravel is sub-rounded quartzite and flint, and sub-angular brick and concrete. 2.00 - 3.00 Becoming brownish grey with a slight peaty odour			
		3.00 - 4.00 Becoming brownish grey very clayey very silty gravelly with numerous cobbles.	3.90	D

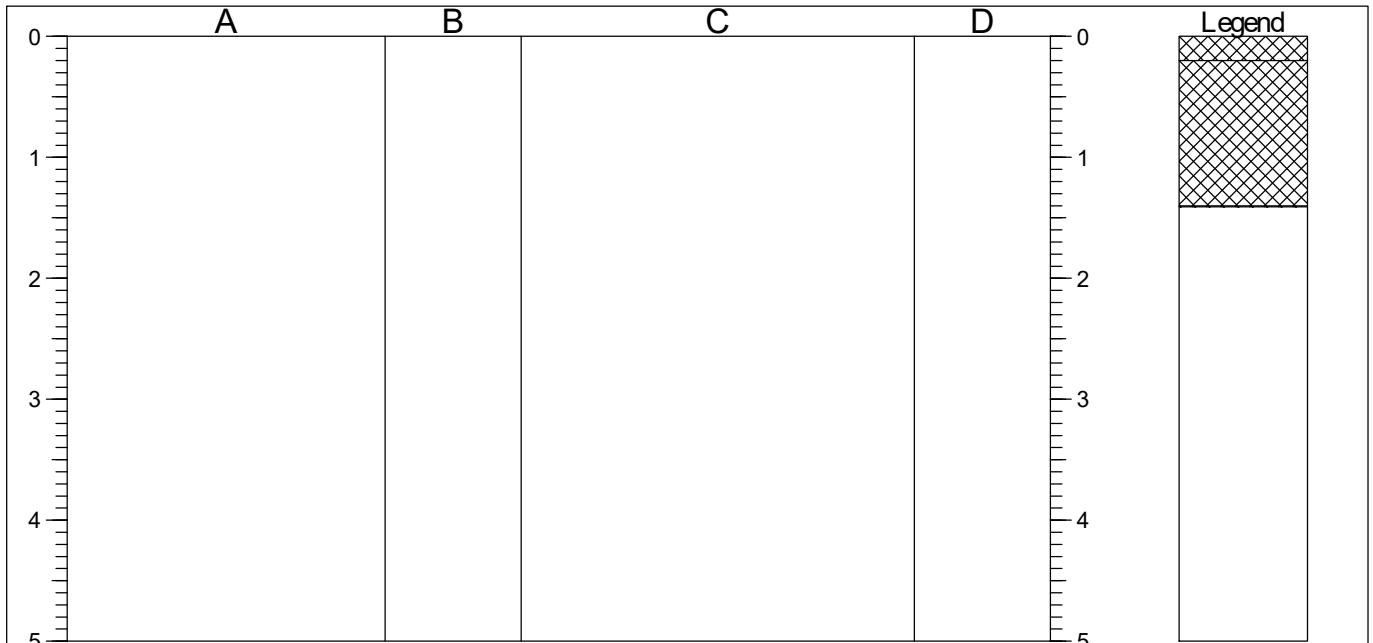
Project Adastral Park, Ipswich, IP10 0BL - Area 2				TRIAL PIT No TP01
Job No GEG-16-458	Date 18-10-16	Ground Level (m)	Co-Ordinates () E 625,599.8 N 244,975.2	
Contractor				Sheet 1 of 1

STRATA			SAMPLES & TESTS		
Depth	No	DESCRIPTION	Depth	No	Remarks/Tests
0.00-0.20		MADE GROUND - (Loose) dark brown slightly clayey slightly gravelly fine to medium SAND with occasional rootlets. Gravel is sub-rounded quartzite.	0.90	D	
0.20-1.40		MADE GROUND - (Medium dense to dense) light brown fine to medium clayey slightly gravelly SAND with rare to occasional cobble-sized fragments of concrete. Gravel is sub-rounded to sub-angular flint, chert, chalk and concrete.			
1.40-1.41		MADE GROUND - (Very dense) grey COBBLES of concrete.

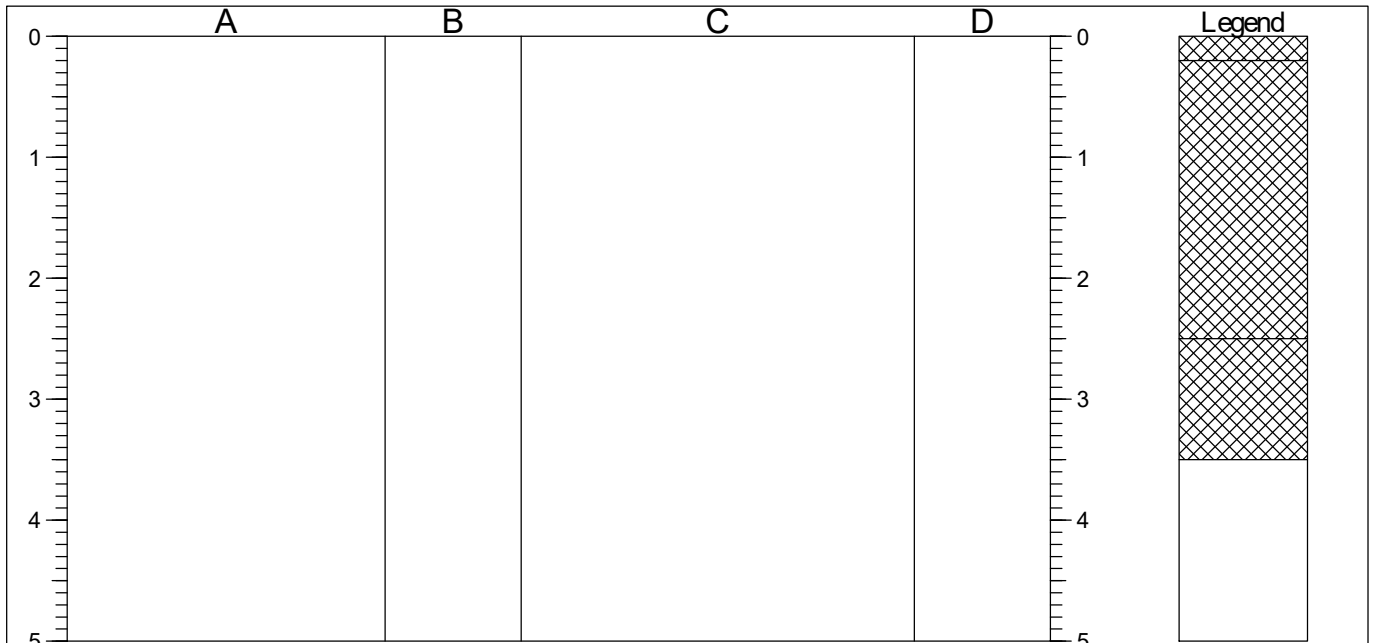
Project Adastral Park, Ipswich, IP10 0BL - Area 2				TRIAL PIT No TP02
Job No GEG-16-458	Date 18-10-16	Ground Level (m)	Co-Ordinates () E 625,650.3 N 245,043.4	
Contractor				Sheet 1 of 1

STRATA			SAMPLES & TESTS		
Depth	No	DESCRIPTION	Depth	No	Remarks/Tests
0.00-0.20		MADE GROUND - (Loose) dark brown slightly clayey slightly gravelly fine to medium SAND with occasional rootlets. Gravel is sub-rounded quartzite.	0.20	D	
0.20-2.50			MADE GROUND - (Medium dense) brown slightly gravelly fine to medium SAND with occasional gravel-sized fragments of tile. Gravel is medium fragments of brick and concrete.	1.30	
2.50-3.50		MADE GROUND - (Medium dense) greyish brown gravelly medium SAND with rare gravel-sized fragments of tarmacadam. Gravel is medium fragments of brick and concrete.	2.70	D

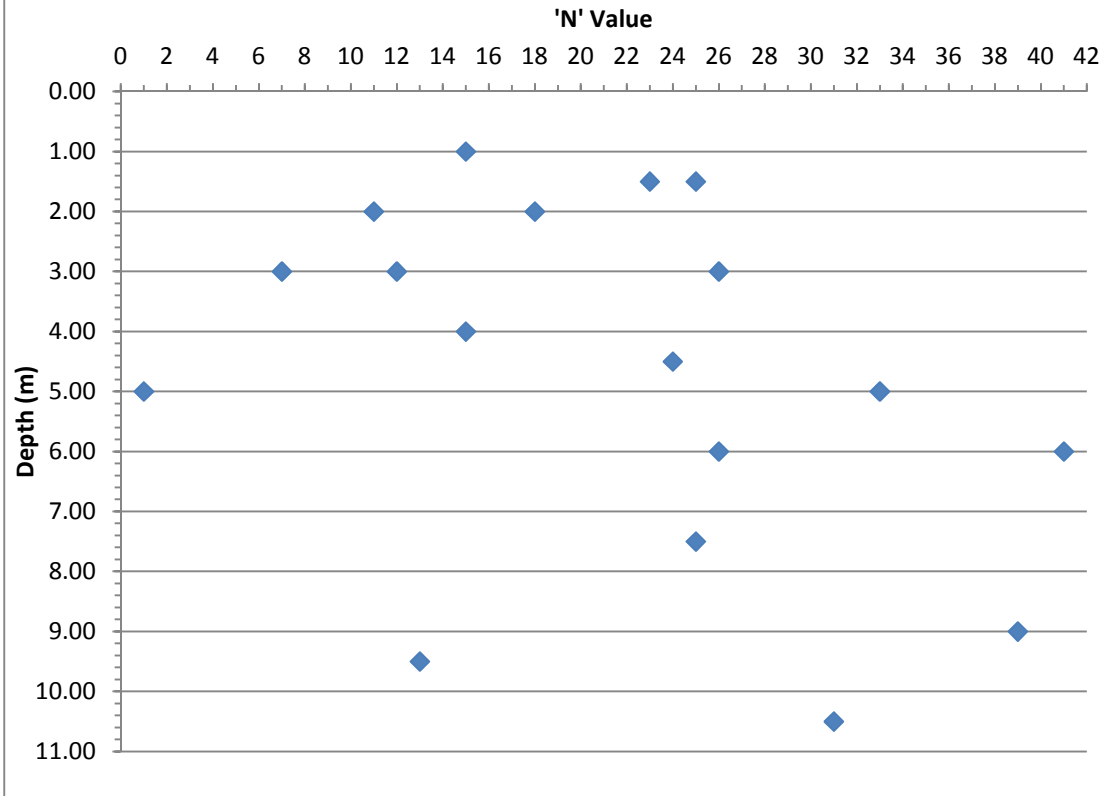
Graph 2. SPT 'N'-Value vs Depth (Granular Solid Strata, Area 1)

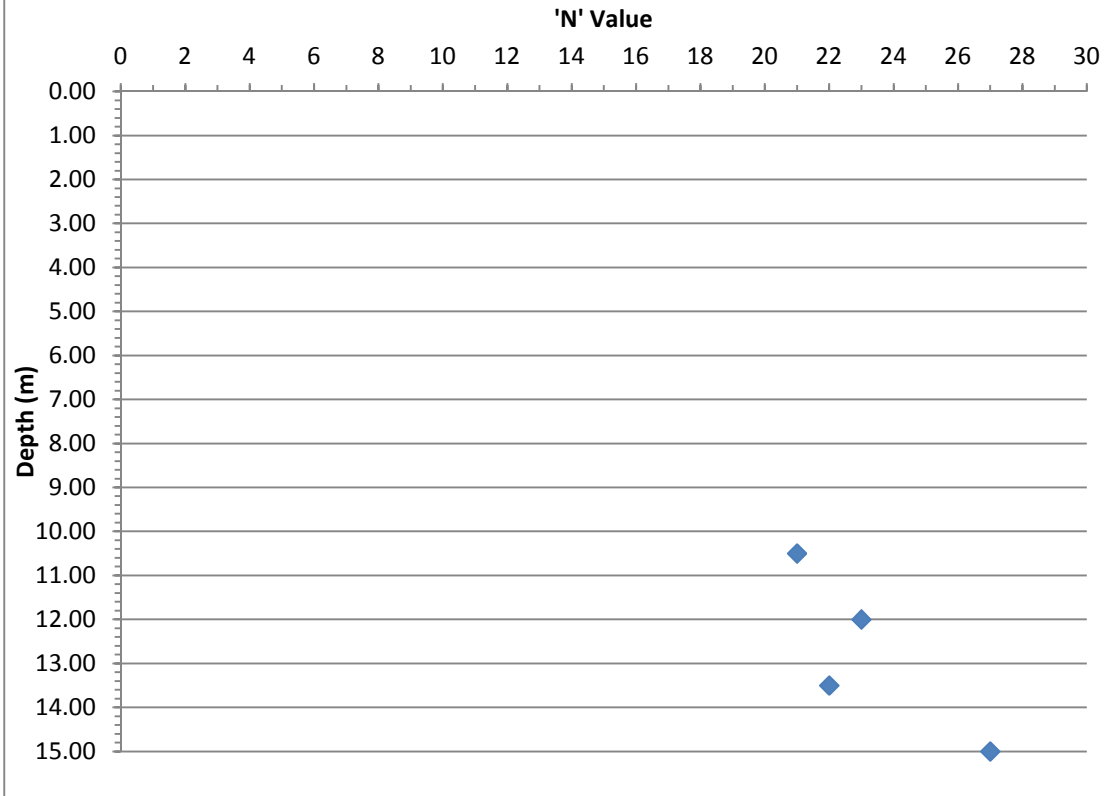
Graph 3. SPT 'N'-Value vs Depth (Cohesive Solid Strata)

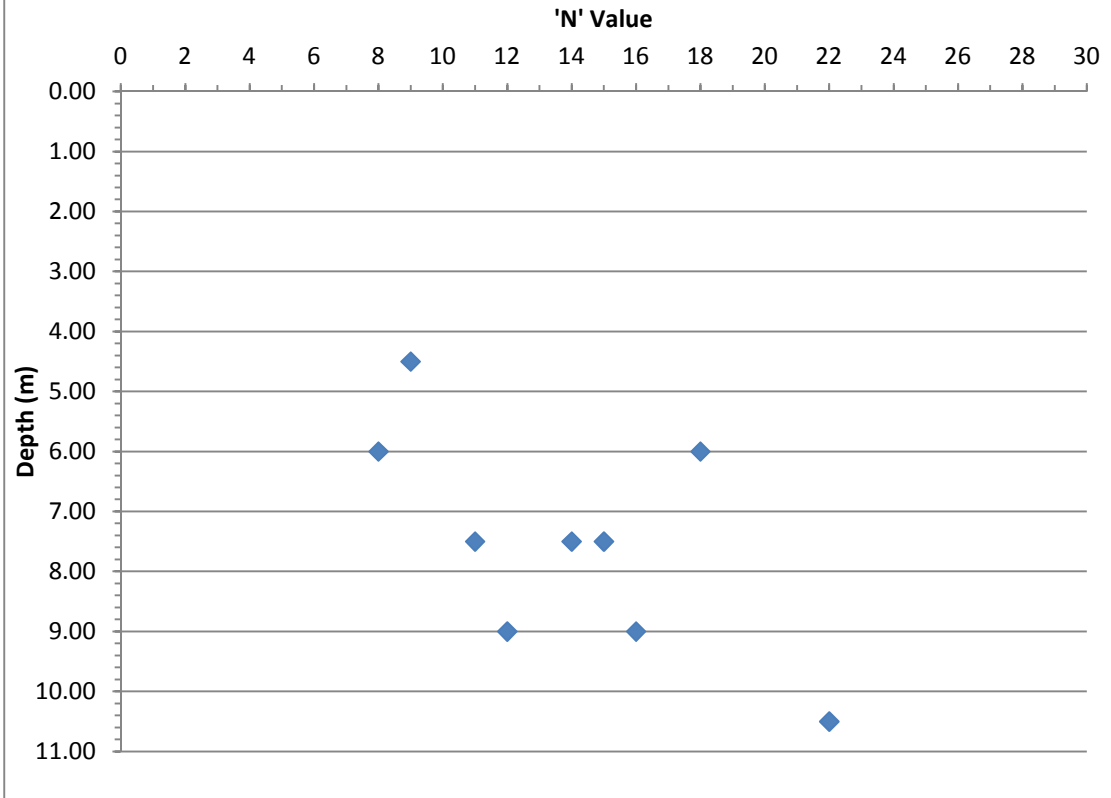
Graph 4. SPT 'N'-Value vs Depth (Granular Solid Strata, Area 2)
