Research and conservation of historic decorative schemes in the built environment

July/August 2020
2020/06

Project Name: Paint Analysis
59/59A High Street, Lowestoft

Report Author: Paul Croft

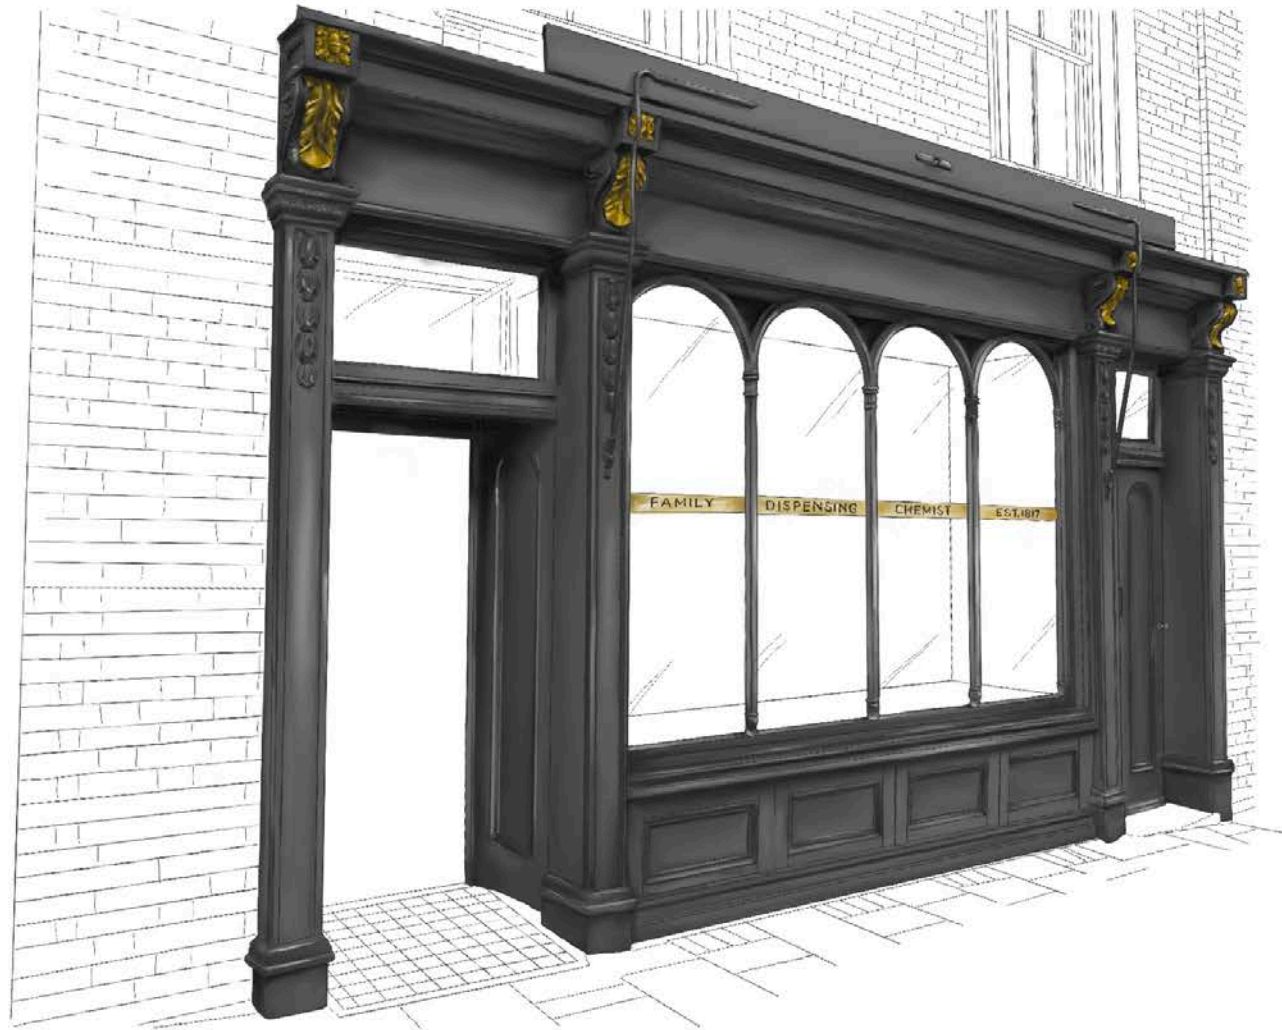
This reconstruction of the shop façade is based purely on the evidence uncovered during this research exercise.

All joinery painted black with gilded highlights applied to the acanthus leaves on the console brackets.

Although the acorns were not sampled, it is assumed they would have been gilded to complement the acanthus beneath.

Figure 16: option 1 - reconstructed 19th century facade

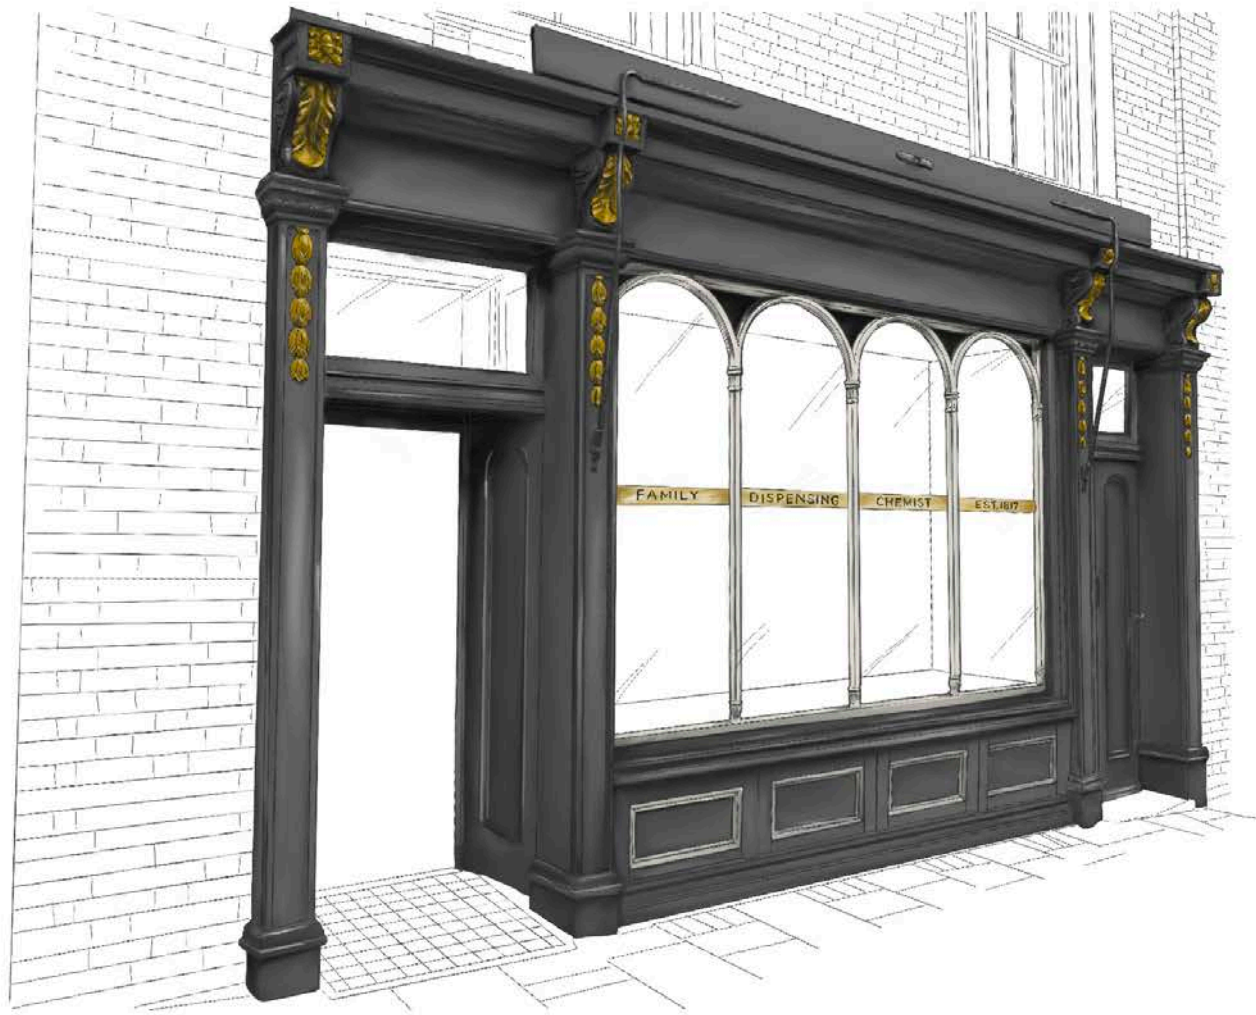
Figure 17: option 2 - reconstructed 19th century facade

This second reconstruction presents the façade as previous in black, with the acanthus leaves and acorns gilded.

However, here the evidence for white painted panel mouldings beneath the windows has been included and extrapolated onto the window and window frame.

The husks adorning the top of the pilasters framing the doors have also been gilded, to further complement the other architectural features above.

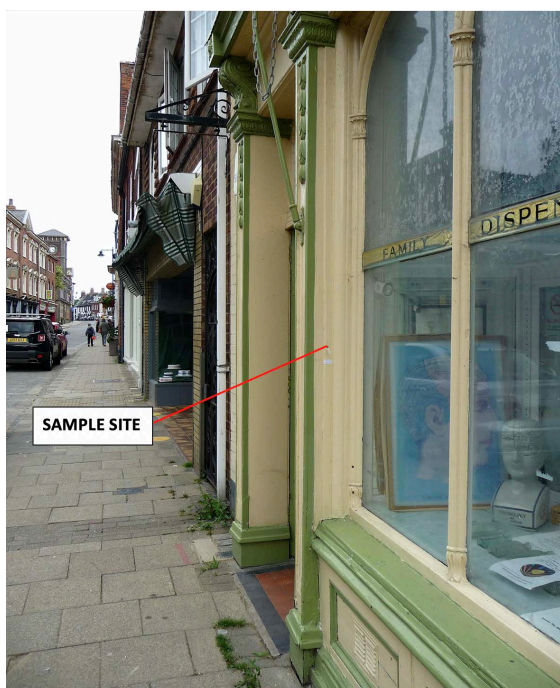
Results of XRF analysis using Bruker Titan 600 analyzer

Element		Min [ppm]	Conc. [ppm]	Max [ppm]	Stddev. [ppm]
Calcium	Ca		110012.00		573.00
Titanium	Ti		22790.00		249.00
Iron	Fe		7279.00		296.00
Barium	Ba		5021.00		141.00
Lead	Pb		2033.00		67.00
Zinc	Zn		165.00		25.00
Arsenic	As		< LOD		24.00

The presence of calcium (Ca) and barium (Ba) suggest the use of chalk and barytes as extenders added to bulk the paint

titanium, iron and zinc added as pigments

No arsenic based pigments were detected.

Lead is present at over 2000 ppm and will have been added as either a pigment or drier. It is present in varying concentrations in the paint layers throughout the shop front.

The paint should be considered lead containing material and treated accordingly.
