Land South and East of Adastral Park, Ipswich
Proposed Western Signalised Access
A12 Dual Carriageway

Stage 1 Road Safety Audit

Adastral Park, Ipswich : Off-site Highway Mitigation to Foxhall Roundabout

Technical Note : Designer's Response to Road Safety Audits at Stage 1

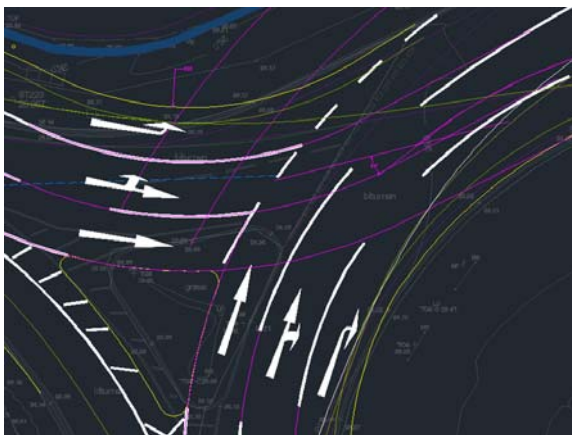
Figure 2a: Approach from Foxhall Road into Roundabout

Summary: Risk of collision with central island and sideswipes. The extension of the arc from the splitter islands guides drivers into the circulatory island and to an extent the resultant alignment of the central lanes also guides drivers towards the central island, risking poor lane discipline.

BCL Response: *This is already the case as demonstrated in the screen captures in Figures 2a and 2b for the aforementioned roads.*

Recommendation: Realign the splitter islands so the extension of the arc is tangential to the circulatory island and make associated amendments to the central lane markings.
