Phase 1 (Desk Study) Ground Contamination Report

Residential Development,
Area 8, Rendlesham, Woodbridge

Capital Community Developments

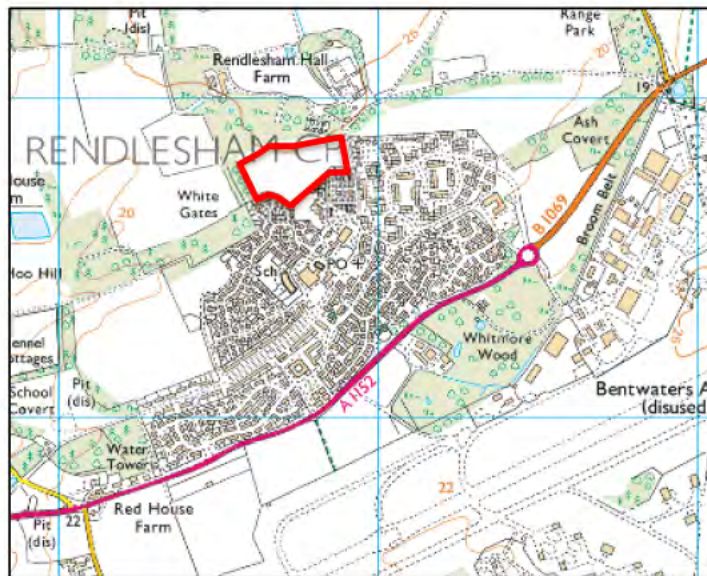
Figure 2.1: Site Location Plan

- 2.1 The Site is located along the northern edge of Rendlesham, as shown in Figures 2.1 and 2.2 below, and is arable farmland. Land to the east and south is formed by residential properties, with woodland and agricultural land to the west and north belonging to Rendlesham Hall Farm. Access can be gained from a private track leading to the farm. A sewage works is present just north of the Site boundary.

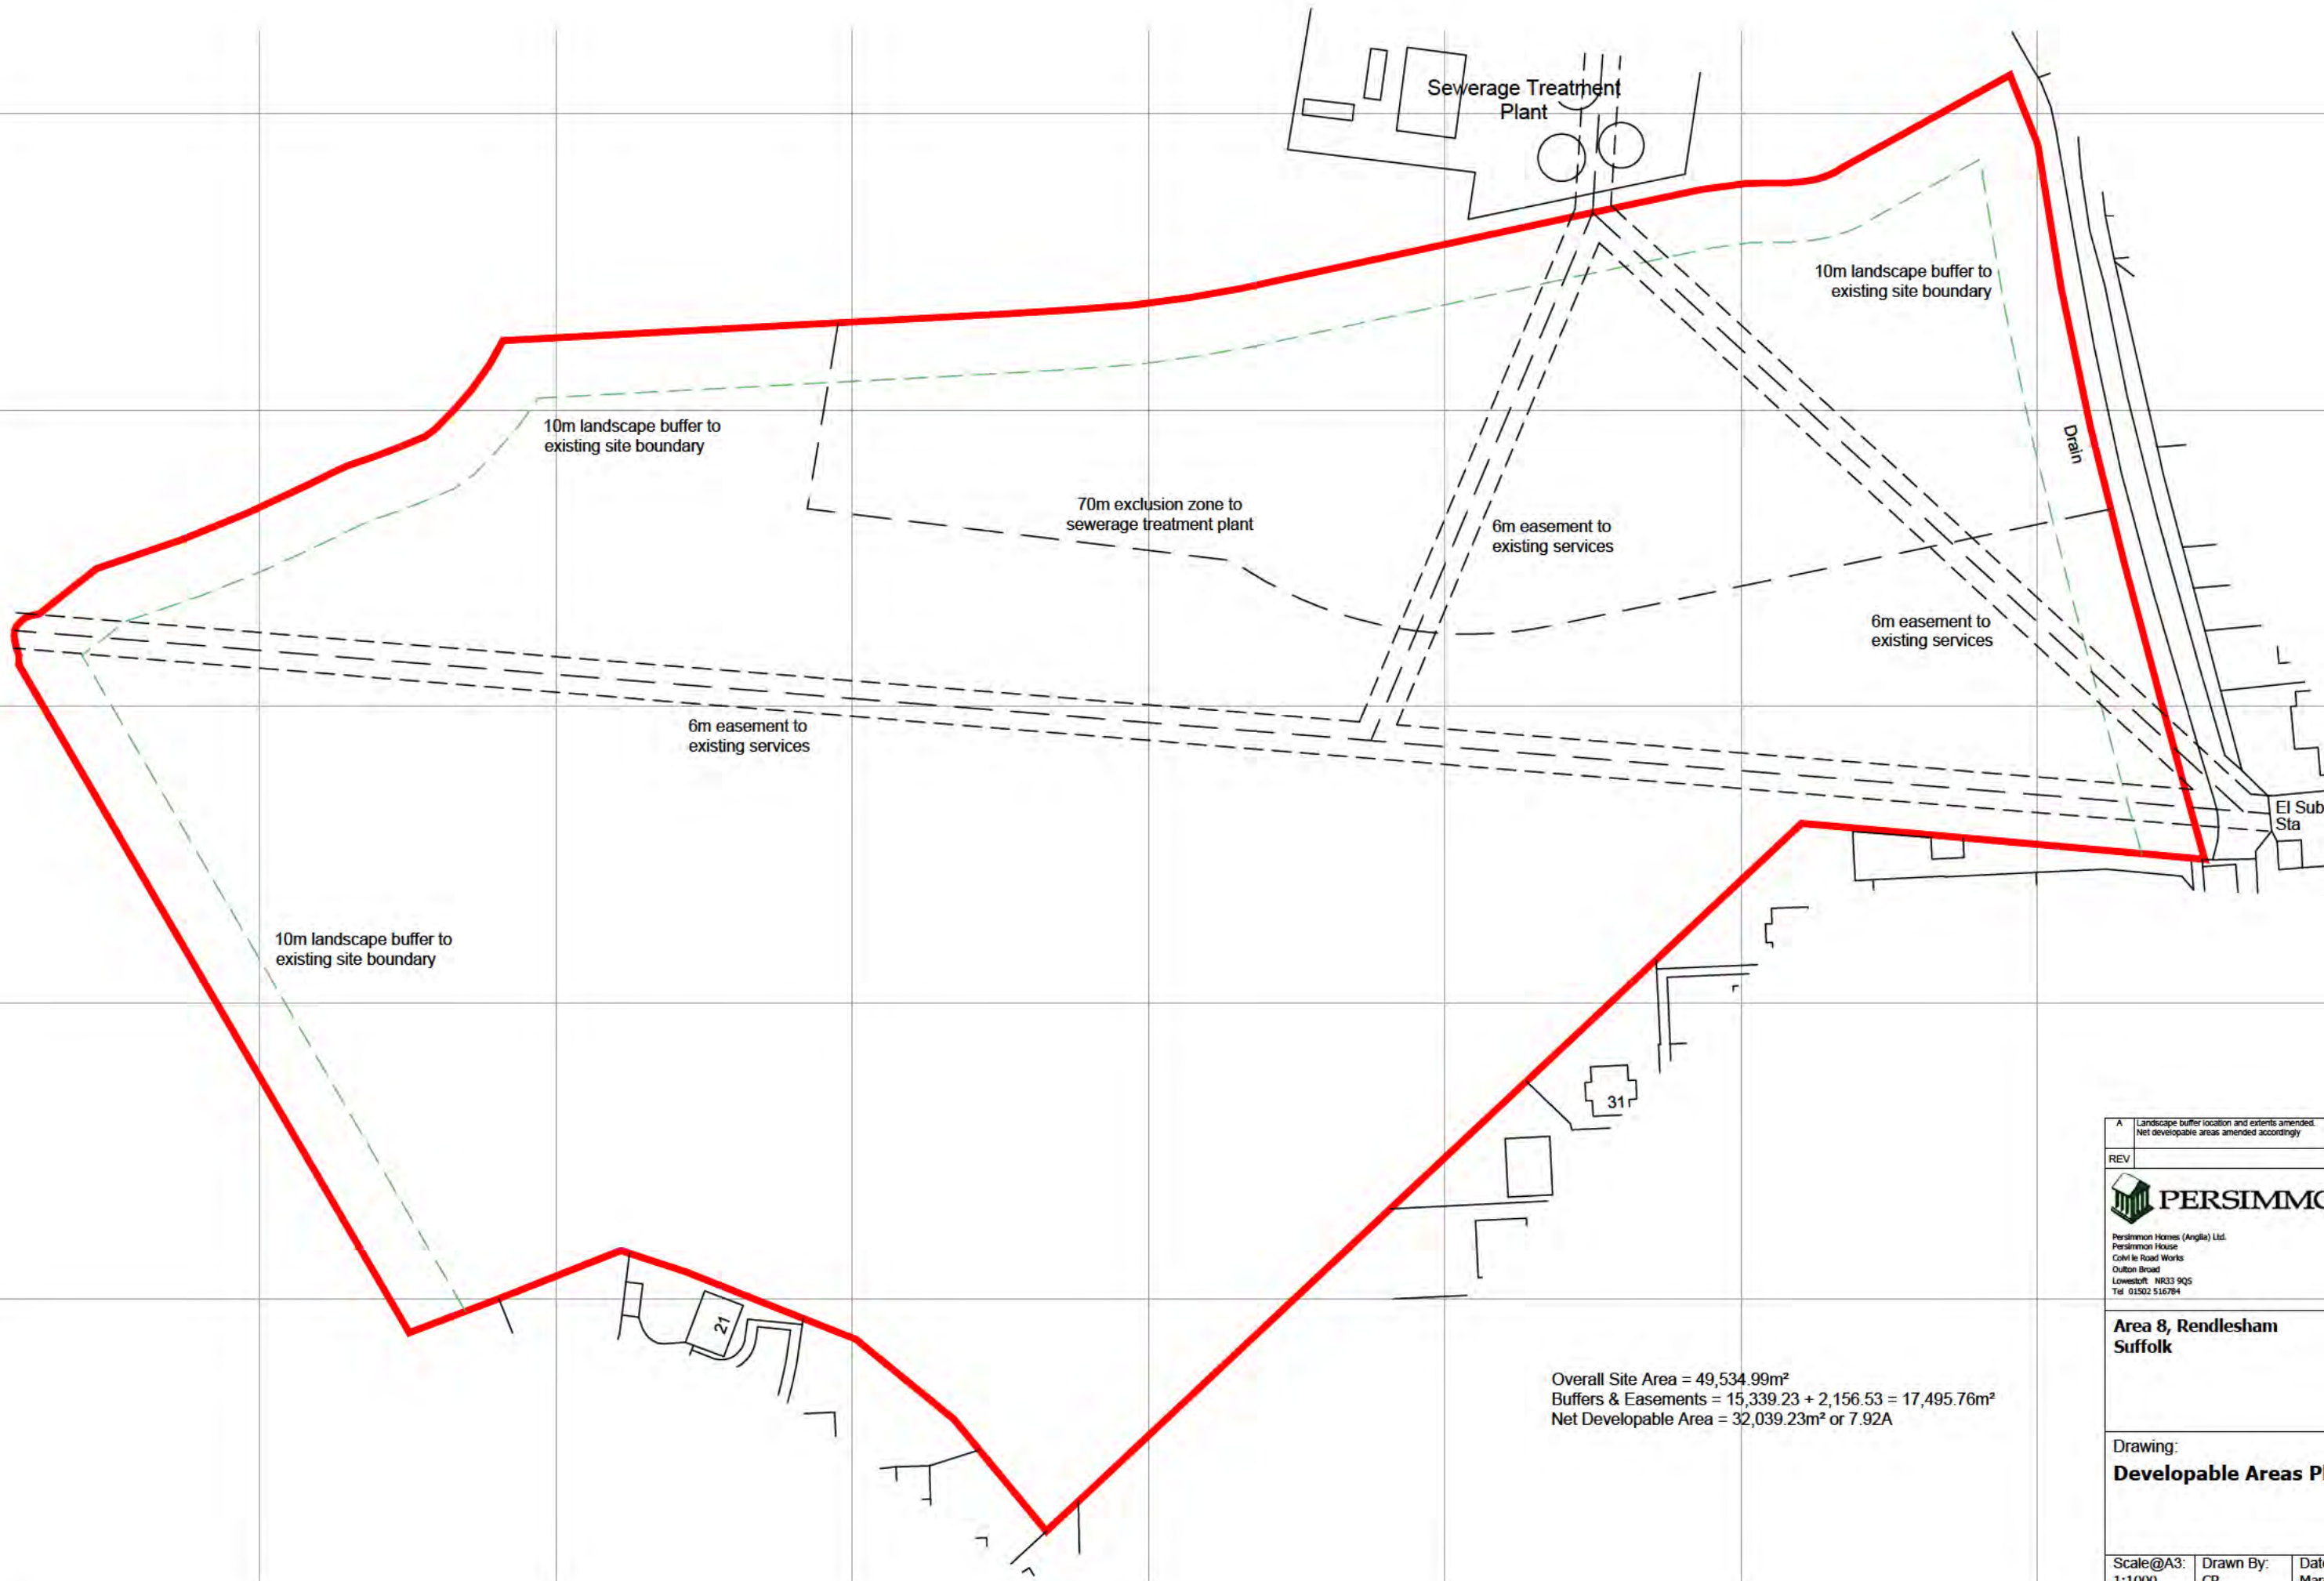
Appendix A: Developable Areas Plan

A	Landscape buffer location and extents amended. Net developable areas amended accordingly	17.03.16
REV		DATE
