Appendix 4: Structures that make a positive contribution to the Conservation Area

4.A – The Castle Character Area

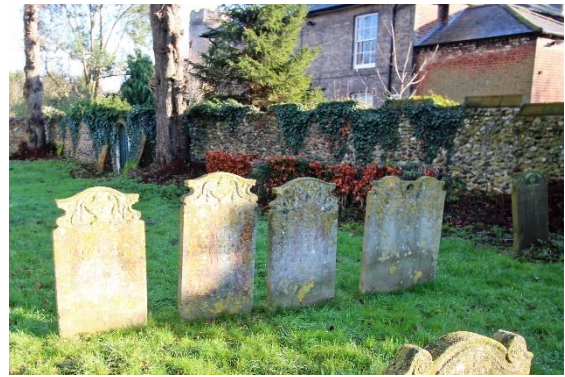
St Mary' Church, St Mary's Street

St Mary' Church and Benedictine Abbey Ruins, St Mary's Street (grade I). A former parish church, closed 1977, and now redundant. Originally this was the Church of the Holy Cross, attached to a Benedictine nunnery, the ruins of which partially survive to the east side of the church. The nunnery was dissolved and partially dismantled at The Reformation and then badly damaged in the fire of 1688. Nave, aisle and porch primarily fifteenth century. The late fifteenth century tower is arguably the dominant feature in the townscape. Its parapet and battlements are of 1702. Octagonal buttresses carried above the parapet as pinnacles. Fire damaged 1688, internally refitted and south aisle re-roofed, as dated on a rafter, in 1699. Church

reopened in 1701. There is no chancel. Vestry of 1819 with wooden tracery in window. Church altered 1832. Nineteenth century restorations by Thomas Jekyll & RW Drew 1861-5, and Richard M Phipson 1879. Much stained glass destroyed in WWII. Bettley, J, and Pevsner, N, *The Buildings of England, Suffolk: East* (London, 2015) p.148-150. Tricker, R *The Priory Church of St Mary Bungay* (London, 2015).

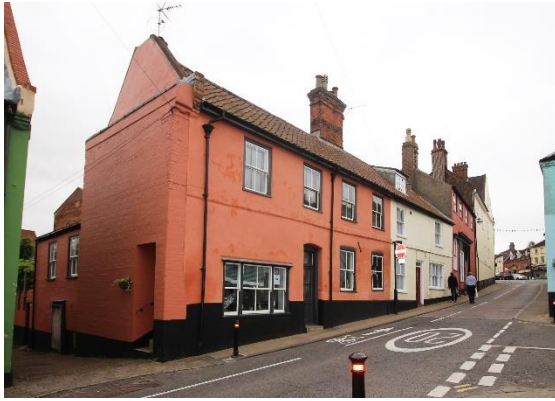
Nos. 4, No. 6a, & 6b Bridge Street

Nos. 4, No. 6a & 6b Bridge Street and garden walls to rear. (grade II). Standing on the corner of Borough Well Lane and probably of early eighteenth century date. Of two storeys and an attic, with a low two storey rear range facing Borough Well Lane. Rendered and painted with a platt band below the first-floor windows. Four-light plate glass sashes with horns to the first floor. One gabled dormer to No.4 within a replaced red pan tiled roof. No.4 is shown with a shop fascia to the ground floor right on c1920 photographs, but this has been replaced by a tripartite sash. To the left of the four-panelled front door is a relatively recent four-light horned sash, in a segmental arched opening. A small central window at first floor level is also shown on early photographs. To the rear of No.4 is a red brick range with an elevation facing a yard off Trinity Street. This has a black pan tiled roof to Borough Well Lane and a red pan tiled roof to its other faces. A late nineteenth century wooden oriel window is set within the end wall at first floor level. Below this window there was evidently a further recently demolished single storey projection

missing. Four-light plate glass sashes to rear range fronting Borough Well Lane. Nos.6a & 6b were once the Green Dragon Public House and are shown as a public house on the 1885 Ordnance Survey map. The pub reputedly closed c1909. Nos.2, 4, 6a & 6b, 12 to 20 (even) 24 to 34 (even), 40 to 44 (even) 48 and 50 form a group. Reeve C, *Bungay Through Time* (Stroud, 2009) p57. Honeywood F, Reeve C, & Reeve T, *The Town Recorder, Five Centuries of Bungay at Play* (Bungay, 2008) p97 & 132.

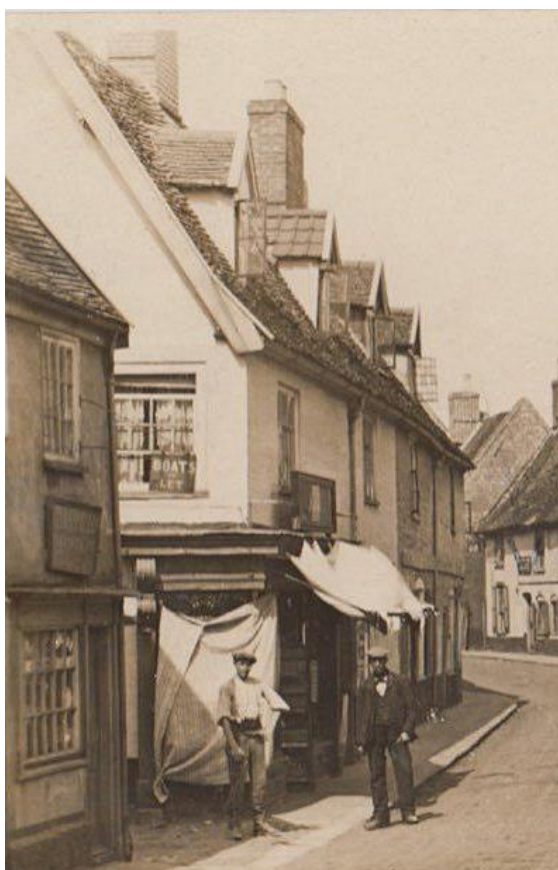
No. 29 Bridge Street

No.29 Bridge Street (grade II). Seventeenth century, of two storeys and an attic. Steeply pitched red pan tiled roof with two flat roofed dormers. C1900 photographs however show the building with gabled dormers. Cement rendering on brick, with a first floor platt band. First floor lit by two three-light casements which replaced the sash windows shown on early photographs. Early nineteenth century six panelled front door described in statutory list now replaced with a partially glazed one. Good doorcase with pilasters and a dentilled cornice. Ground floor shop fascia replaced by further casements. Single storey range to rear with casement windows and a red pan tiled roofed. Nos.29 to 45 (odd) form a group. Honeywood F, Morrow P & Reeve C, *The Town Recorder, A History of Bungay in Photographs* (Bungay, 1994) p156.

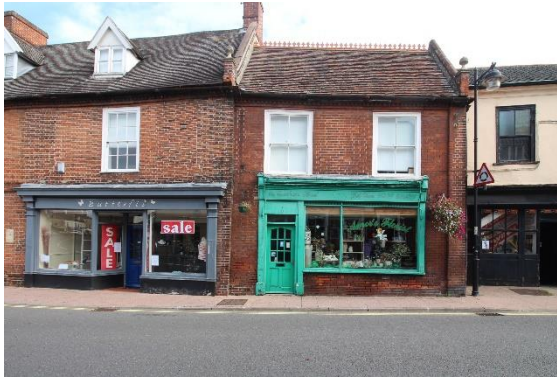
No.4a Earsham Street

No.4a Earsham Street. A structure of c1870 consisting of a shop with living accommodation above which replaced a timber-framed gabled building which is shown on early photographs. Of two storeys and two bays and faced in red brick with a red plain tile roof and terracotta ridge pieces. Southern gable with finials and dentilled cornice. Its present façade is radically different from that shown in Edwardian photographs, which show a central canted bay window at first floor level and a central doorway flanked by two small pane sashes below. Four light horned plate glass sashes at first floor level. Dentilled eaves cornice. Early to mid-twentieth century shop fascia, with late twentieth century partially glazed door inserted post 1977 within the original fascia. Reeve C, *Bungay Through Time* (Stroud, 2009) p38.

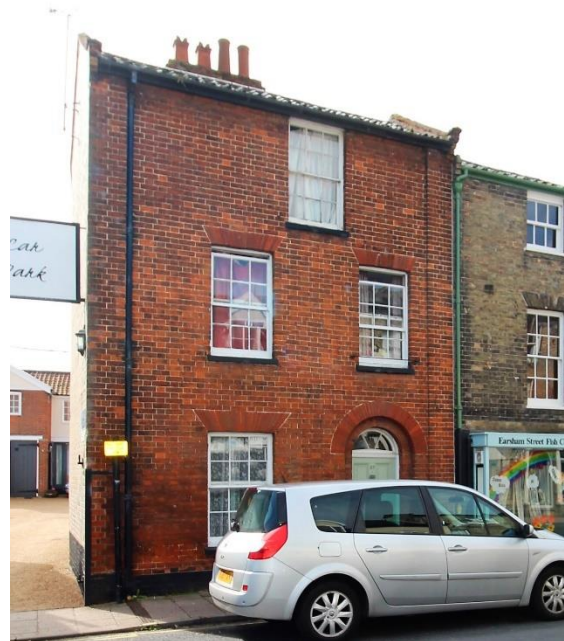
No.37 Earsham Street

No.37 Earsham Street. A red brick dwelling of c1830-40 with a two bay three storey principal façade. Two storeys rear elevation. Pilaster to right of door. Panelled front door recessed within arched opening. Simple semi-circular radial fanlight. Wedge shaped lintels to hornless sash windows and stone sills. Some sashes replaced. Red pan tile roof covering and massive red brick chimneystack. Rear elevation facing the Castle is rendered and painted with four-light plate-glass sashes. Two storey outshot with a red pan tile roof probably of contemporary date. The rear section of the plot on which this building stands is within the scheduled area of the Castle complex.

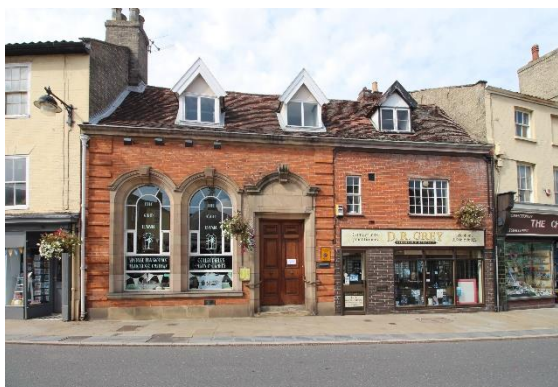
No.8 Market Place

No.8 Market Place. Former bank and shop. c1900 red brick classical façade with stone dressings to an earlier structure. 1880s photos show a stuccoed early to mid-eighteenth century building of similar proportions on this site. Red plain tile roof with a row of three gabled dormers with bargeboards and casement windows. Rusticated red brick pilasters. Full height arched windows to left-hand section with heavy moulded surrounds and pronounced keystones. Doorcase with similar surround with robustly carved scrolled keystone. Right-hand section with small pane metal casement windows to first floor and late twentieth century shop fascia. The rear section of the plot on which this building stands is within the scheduled area of the Castle complex. Honeywood F, Morrow P, & Reeve C, *The Town Recorder, A History of Bungay in Photographs* (Bungay, 1994) p135.

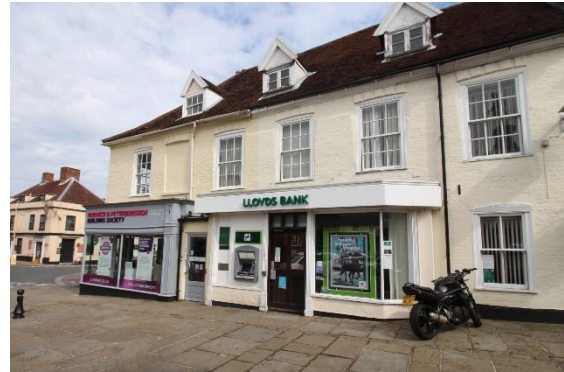
Nos. 9 & 11 Market Place (grade II). An early eighteenth century building on a prominent corner site. Of two storeys with attics which are lit by gabled sash dormers. Colour-washed brick. Red plain tile roof covering. Principal elevation of six bays and a return elevation of four. Flush framed twelve-light hornless sashes beneath rusticated cambered arches to first floor. Entrance door with fanlight and wood case. Mainly modern shop fronts. Originally one building. Essentially part of the old market. Nos. 1 to 11 (odd), Nos. 11A, 13 and Nos. 17 to 21 (odd) form a group together with the Butter Cross.

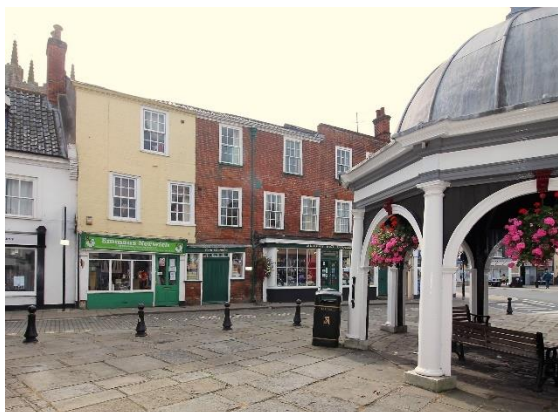
Nos.15-19 (odd) Market Place

Nos.15,17,19,19a & 21 (odd) Market Place (grade II). A three storey eighteenth century red brick range backing onto Saint Mary's Churchyard. Market Place façade of seven bays. With a red pan tiled roof. (No. 15 now painted). Wooden modillion eaves cornice survives to Nos.15-17 but replaced by parapet above Nos.19 & 21. Seven twelve-light sash windows to the first floor in flush frames beneath flat arched lintels. Those to No.19 with horns. Windows to No.17 regrettably replaced by casements. Early nineteenth century wooden shop fascia to No.17. Well-preserved early nineteenth century shop front to part of Nos.19 and 21, with

pilasters and entablature. Nineteenth century glazing bars, except to patterned fanlight. No.15 is described in the listing entry but its numbering is incorrect.

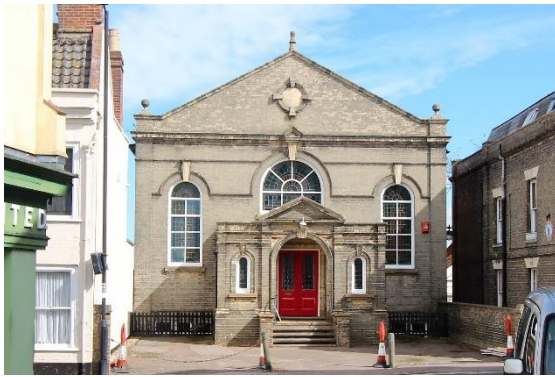
Former Wesleyan Methodist Chapel, Trinity Street

*Former Wesleyan Methodist Chapel, Trinity Street and boundary wall to Borough Well Lane. Former Wesleyan Methodist Chapel with basement schoolrooms built 1836, re-fronted and refitted 1904. Repaired after 1940 bomb damage, in 1948. Closed 1976, when some fittings were removed to Emmanuel Church. Façades to Trinity Street and Borough Well Lane which are well preserved and retain the bulk of their original joinery and stained glass. Its Trinity Street façade terminates views along Cross Street. Pedimented gault brick façade to Trinity Street of three bays with corner pilasters capped by ball finials. Three arched casement windows with pronounced keystones. Pedimented projecting single storey porch. Elevation to Borough Well Lane of an additional storey and faced in red brick. Tall nineteenth century gault brick boundary wall to Borough Well Lane of considerable townscape value. Red brick retaining walls to rear of lesser interest. Honeywood F, Morrow P, & Reeve C, *The Town Recorder, A History of Bungay in Photographs* (Bungay, 1994) p17 & 27. Bettley, J, and Pevsner, N, *The Buildings of England, Suffolk: East* (London, 2015) p.157.*

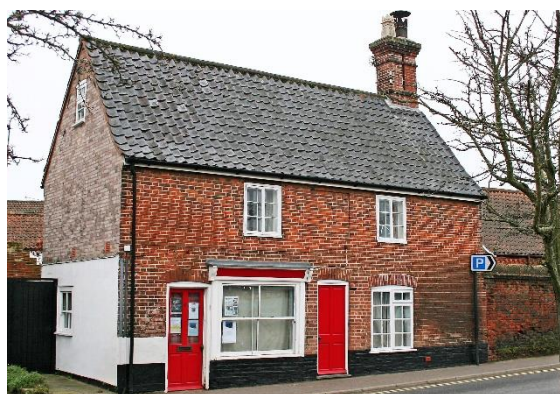
No.4 Lower Olland Street

No.4 Lower Olland Street. Two cottages, latterly house and shop. Red brick with a steeply pitched black pan tiled roof. Possibly late eighteenth century. Well preserved later nineteenth century shop fascia to southern end of a single bay. Two centrally opening casements to first floor which are possibly of nineteenth century date flanking a central blind recess. Southern return elevation partially rendered with replaced windows. Door and widow openings to ground floor with cambered brick lintels. Ground floor window at northern end now a late twentieth century four pane casement. Northern elevation rendered. Single storey rear range.

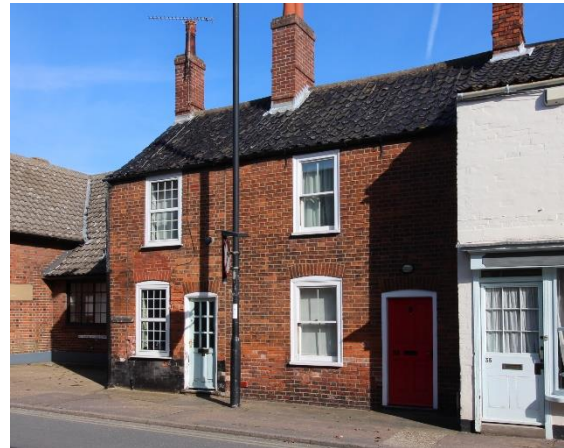
Nos.31-33 (odd) Lower Olland Street

Nos.31-33 (odd) Lower Olland Street. A pair of red brick terraced house of c1800 with a black pan tiled roof. Cambered arched lintels to window openings. External joinery replaced in the late twentieth century. Straight joint between the two properties.

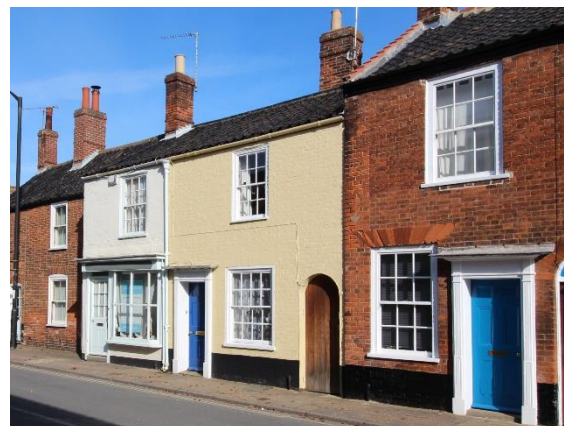
Nos.35-37 (odd) Lower Olland Street

Nos.35-37 (odd) Lower Olland Street. A pair of red brick terraced houses of c1800 both now painted. No.35 with a mid to late nineteenth century shop facia, and a replaced partially glazed door. Twelve-light hornless sashes. Black pan tiled roof. Simple pilastered doorcase to No.37 and arched passage entrance.

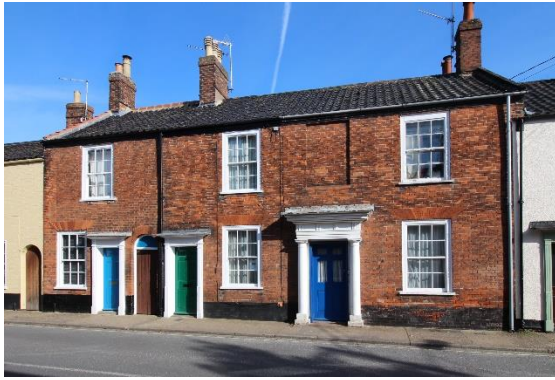
Nos.41-45 (Odd) Lower Olland Street (grade II). Later eighteenth or early nineteenth century, of two storeys, red brick, black pan tiled roof. Six bay façade with replaced sash windows within flush frames to each floor. Flat arched lintels to ground floor. Nos.41 and 43 have six-panelled doors in wooden cases with pilasters. No.45, a six-panelled door within an altered wooden doorcase with Doric pilasters. Blind recess above. Arched passage between Nos.41 and 43,

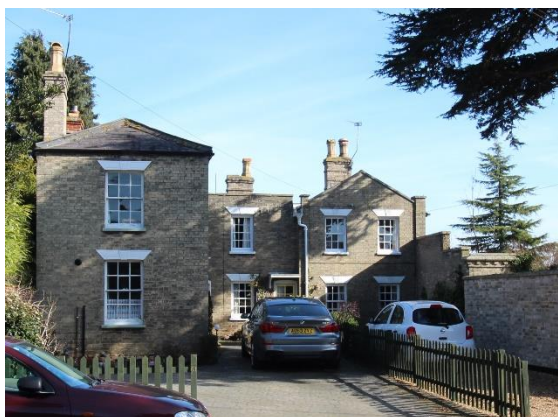
Nos.61 & 63 Lower Olland Street

*Nos.61 & 63 Lower Olland Street. A semi-detached pair of houses of mid nineteenth century date. Possibly originally one villa but map evidence suggests it has been divided since at least 1905. Two storeys. L-shaped, No.61 within projecting range at northern end with a hipped Welsh slate roof. Good Doric doorcase. Twelve-light hornless sashes beneath painted stone flat-arched lintels with rusticated panels. No.63 has parapet hiding roof and gable to southern bays. Twelve-light hornless sashes. *Subsidiary Structures.* Tall mid nineteenth century gault brick wall springing from entrance façade of No.63.*

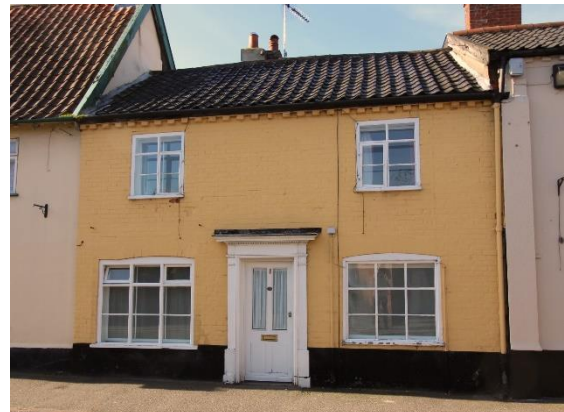
No.20 Upper Olland Street (grade II). Eighteenth century with a two storey, three bay symmetrical façade of painted brick. Black pan tiled roof. Dentilled brick eaves cornice. Two flush casements at first floor level. Central doorcase with pilasters and a dentilled cornice. Partially glazed four-panelled door flanked by two six-light casements beneath cambered brick arches. The left-hand casement is slightly wider than its lintel and replaces a late nineteenth century pub facia. Formerly the Greyhound Inn (closed 1913). Honeywood F, Reeve C, & Reeve T, *The Town Recorder, Five Centuries of Bungay at Play* (Bungay, 2008) p99 % 154.

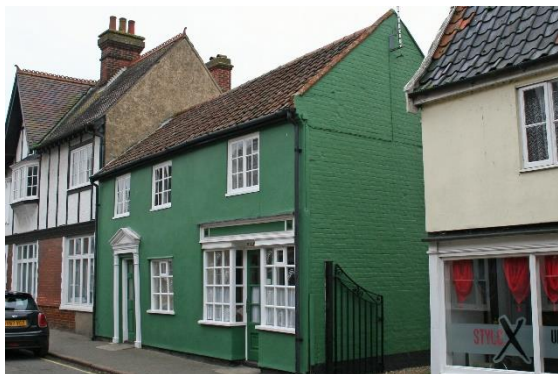
No.26 Upper Olland Street

No.26 Upper Olland Street. Probably of early nineteenth century date but much altered. Painted and rendered red brick. Red pan tiled roof. Three small pane casement windows to first floor. Late twentieth century pedimented doorcase and shop fascia. Whilst much of the external joinery has been replaced the openings correspond to those shown on early twentieth century photographs. The building has significant group value with neighbouring properties.

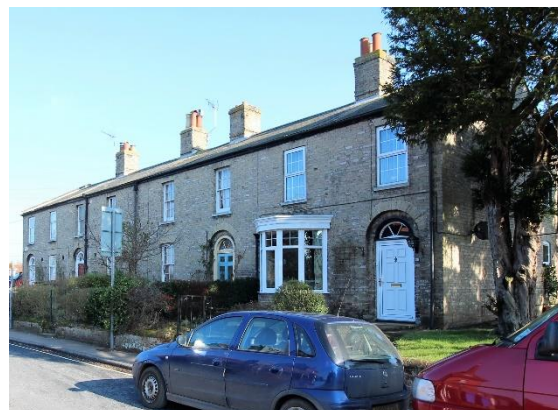
Nos.38-44 (even) Wingfield Street

Prospect Place, Nos.38-44 (even) Wingfield Street. Gault brick terrace of four houses. Two storeys, each house of two bays. Original hornless twelve-light sashes now only survive to No.42. Flat-arched lintels, stone sills. Front doors within shallow arched recesses, radial fanlights. Six-panelled doors now largely replaced. No.38 with late twentieth century canted bay window.

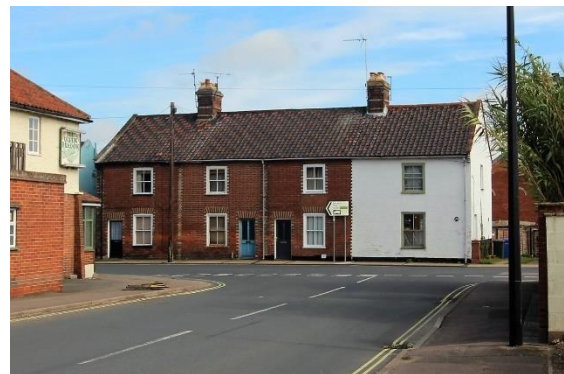
Nos.40-46 (even) Broad Street including boundary wall of No.46 to Stone Alley. A terrace of four later nineteenth century cottages. Red brick with gault brick embellishments. No.40 now painted. Roof covering partially red and blue pan tiles in a geometric design and partially replaced with red pan tiles. Two shared red brick ridge stacks. Four-pane, horned, plate-glass sashes. Gault brick quoins separating cottages, and alternate gault and red bricks to wedge shaped lintels for both doors and windows. Sides of window and door openings also have gault brick embellishments. Partially glazed front doors. No.40's front door has been moved to the return elevation. No.46 has a good series of early nineteenth century or earlier boundary walls of brick and rubble to Stone Alley.
